# Erosion Hazard Assessment Picton Terminal Picton, Ontario

Cambium Reference No.: 6824-001

October 17, 2017

Prepared for: G.D. Jewel Engineering

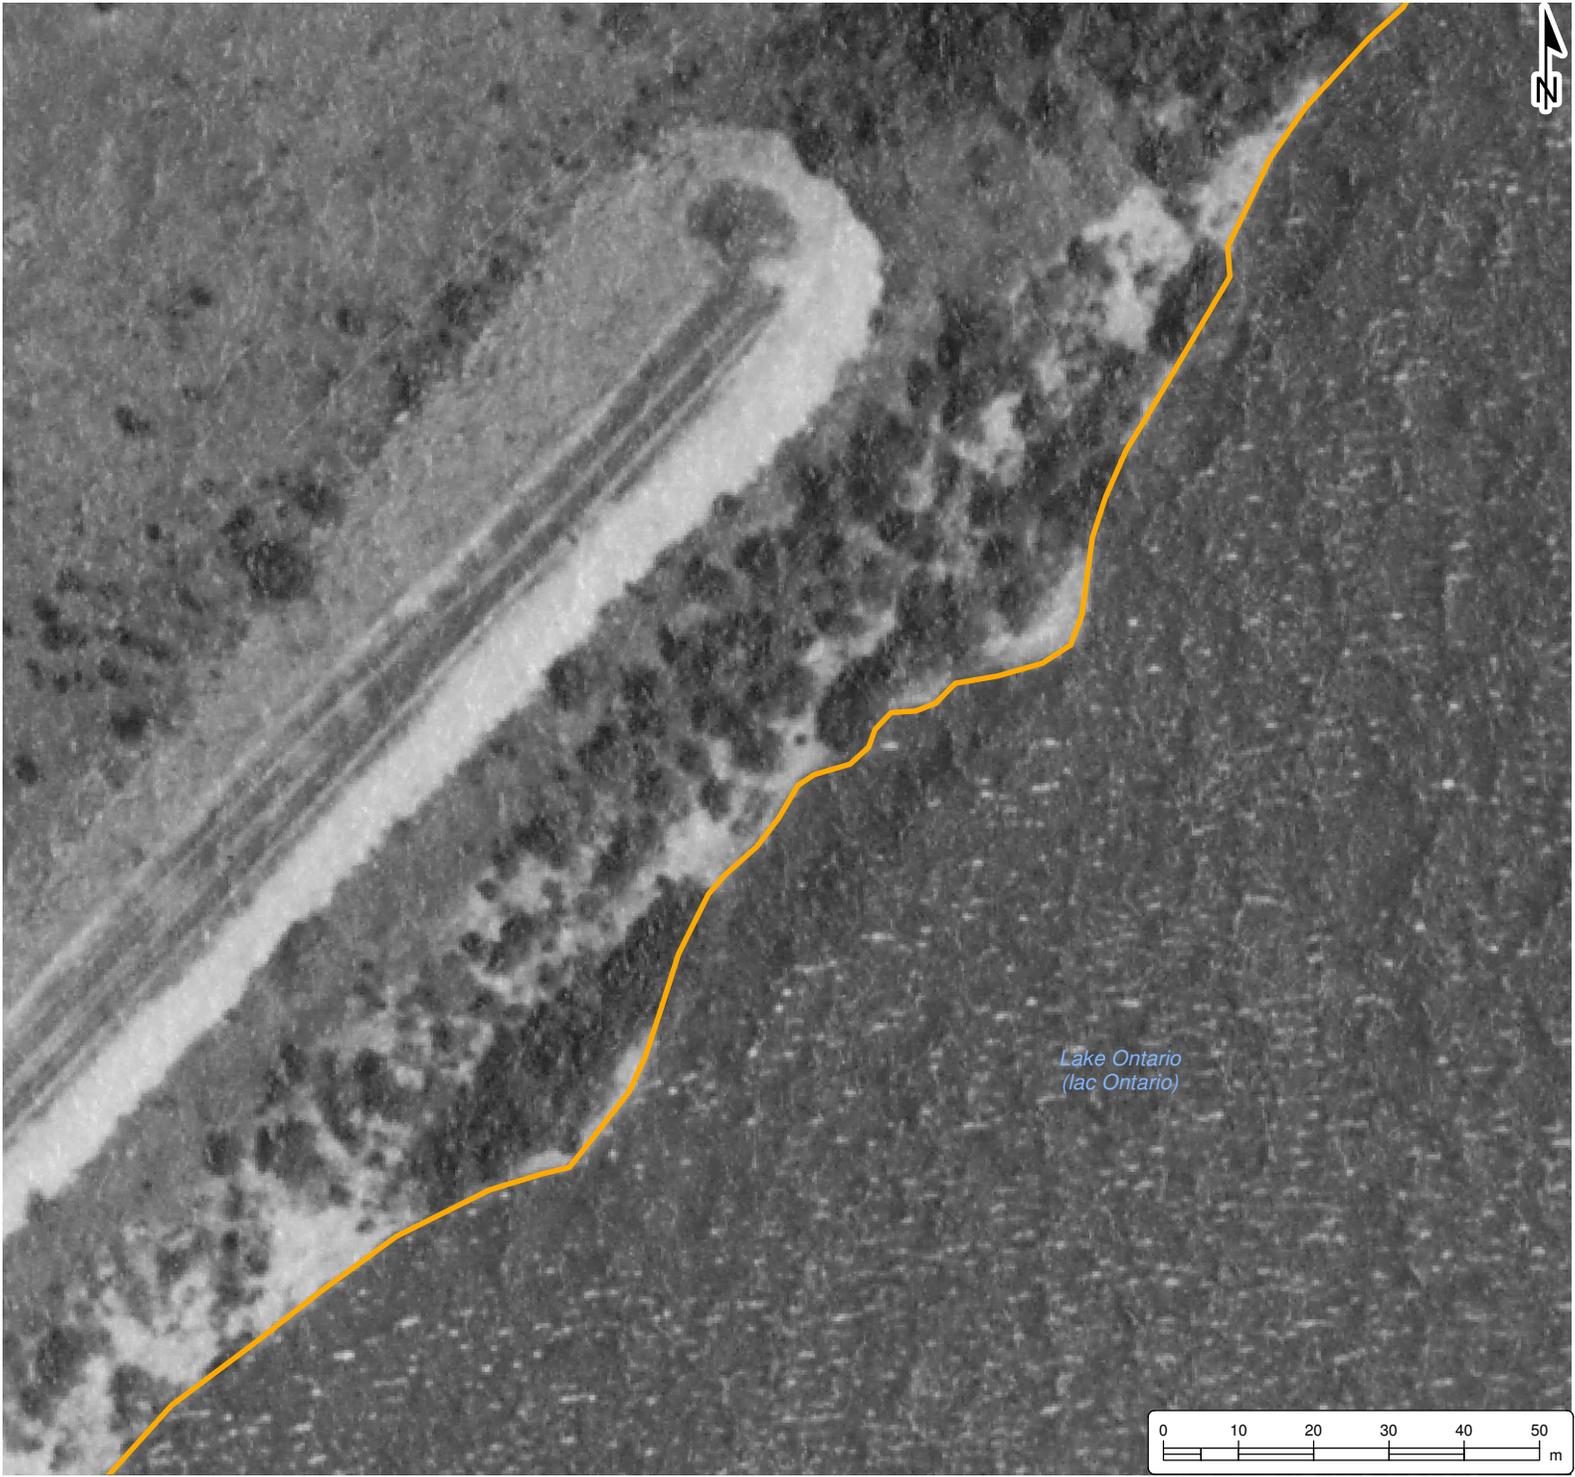
**SHORELINE  
1962 IMAGE**

The toe erosion allowance at this Site is based on the annual average recession rate of the shoreline. Two quality images of the area, taken in 1962 and 2013 and acquired from the National Air Photo Library and ERSI ArcGIS Online respectively, were compared in order to assess the recession of the shoreline over the 51 year

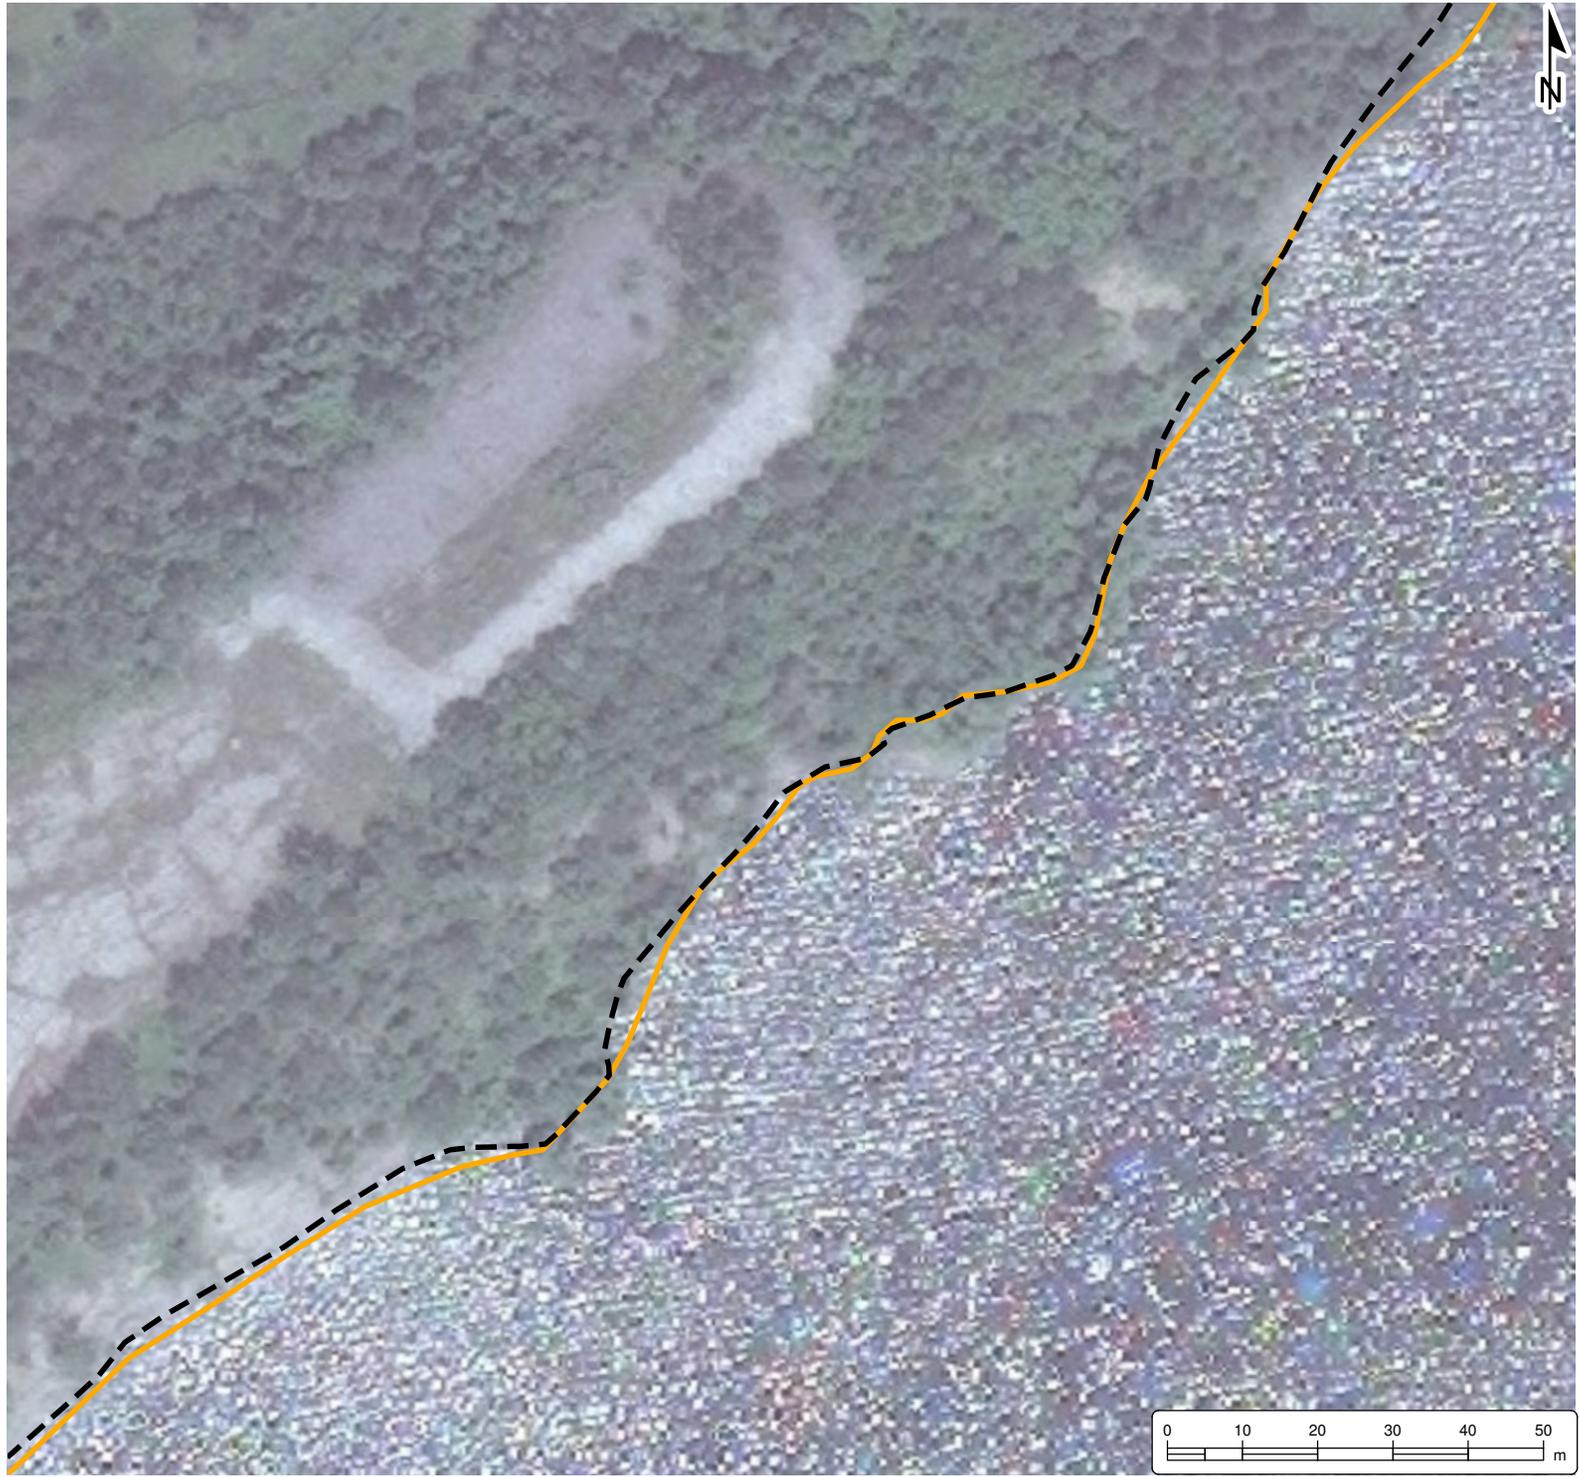
**SHORELINE COMPARISON**

period. Figure 2 depicts the 1962 image of the area and its associated shoreline at that time. Figure 3 depicts the 2013 image with its associated shoreline at the time. For comparison purposes, the 1962 shoreline has been superimposed on the 2013 image in Figure 3. In general the lines match quite well with considerable overlap. The most significant change in shorelines appears to be on either side of the point of detrital material that has been shed and protrudes from the bedrock slope. This material takes the shape of an alluvial fan-like form that is constantly being reworked by wave action. The remainder of the shoreline, in areas of exposed bedrock, has very little erosion, which ranges from 0 m to 2.5 m and averages approximately 1 m along the entire shoreline. As this erosion has occurred over 51 years, the annual average rate of recession is calculated to be 0.02 m/year. When the annual average recession rate is projected over a 100 year development horizon, the erosion is calculated to be 2 m. Based on this information and with some conservatism included, Cambium recommends a toe erosion allowance of 3 m be used for the purposes of this project.

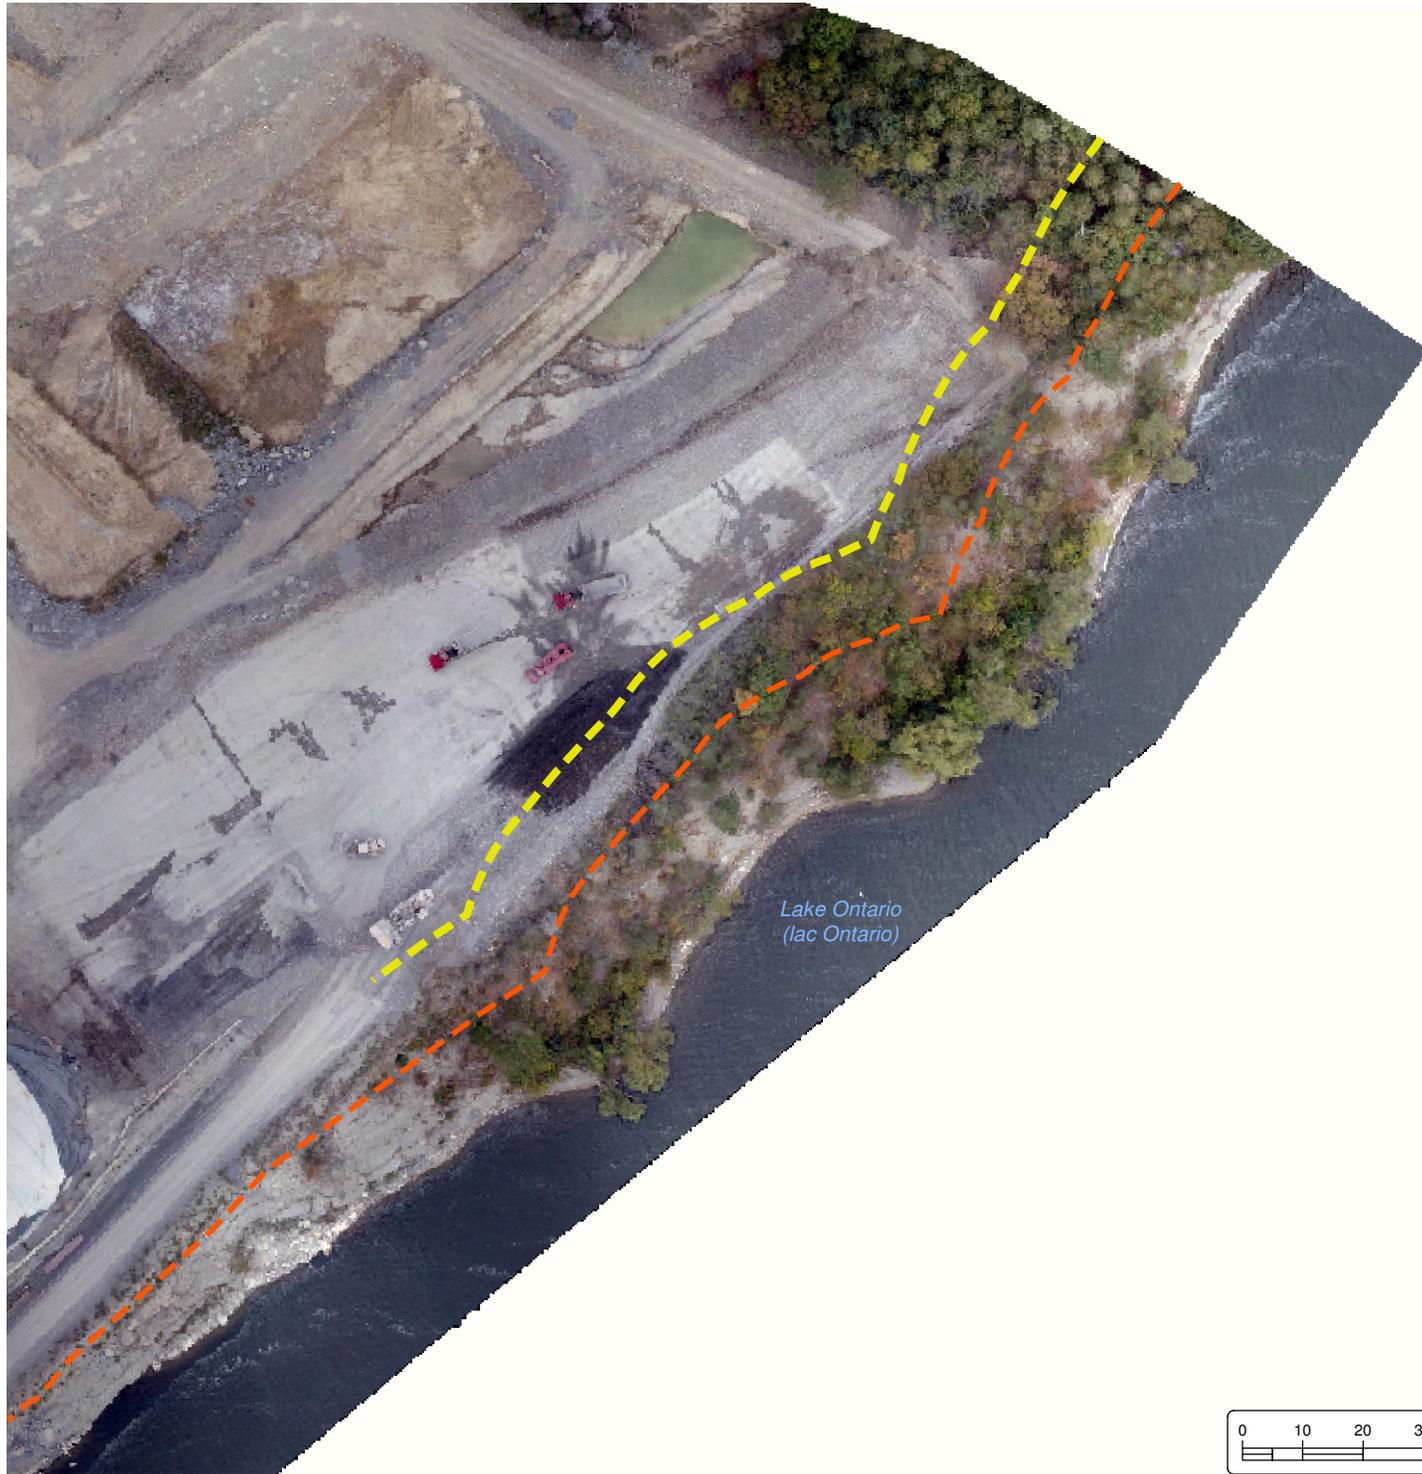
**EROSION HAZARD LIMIT**

The majority of the slope in the subject area has a vertical height of 22 m, and as such an erosion hazard limit setback of 34.4 m from the shoreline, along this relatively consistent plateau. As the ramp extends to south from the plateau, down to the water's edge, the elevation at the top of the slope decreases, and resultingly the erosion hazard limit is also reduced via the stable slope allowance calculation. This maximum erosion hazard limit setback is illustrated in Figure 4.

Based on the nature of the operation at site and the competency of the rock, the slope, and the overall resistance of the shoreline to erosion, it is Cambium's opinion that the additional 15m buffer is excessive and should not be included in the erosion hazard limit. A second line has been included in Figure 4, which depicts the sum of the stable allowance and the erosion allowance, omitting the 15 m buffer.

It should be noted that in areas where the existing slope is currently less steep than the stable slope 0.75H:1V, due to the progradation of a talus material at the base of the slope, the erosion hazard limit shall be modified to be 3 m landward from the top of the slope.

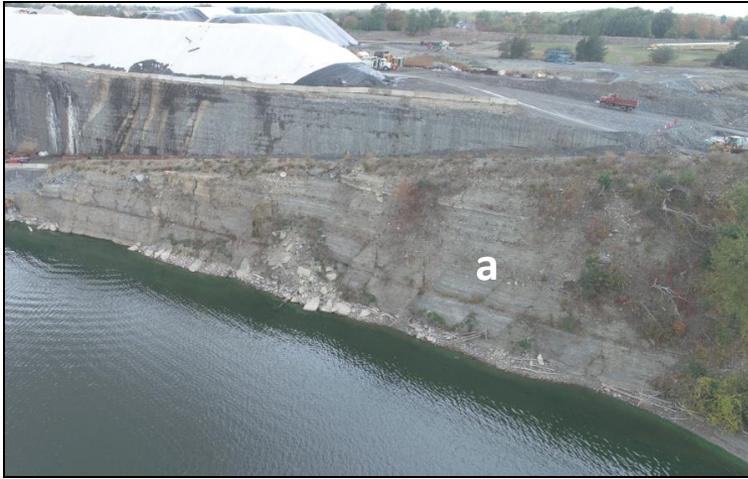
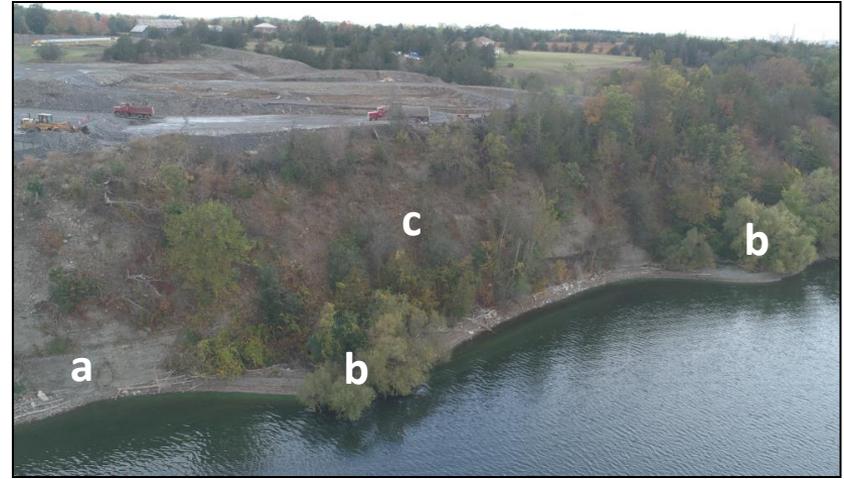
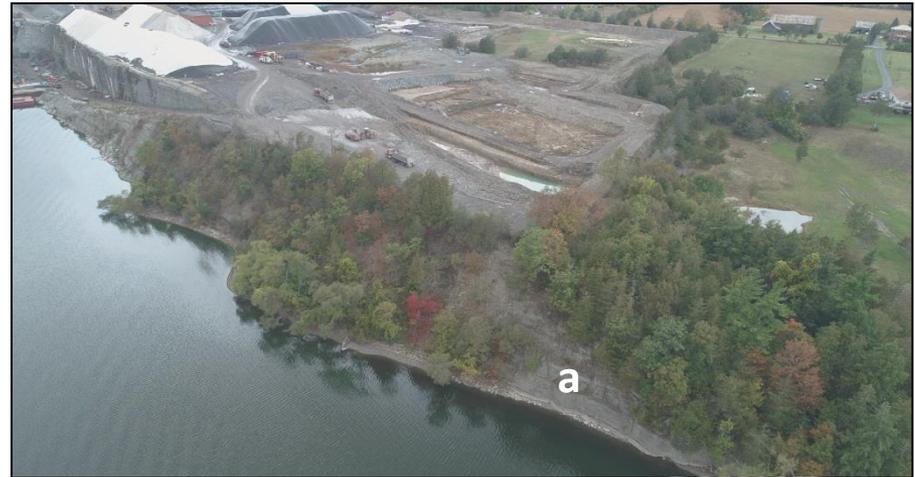
Pictures showing the subject slope. Above: slope adjacent to existing ramp showing (a) exposed limestone bedrock. Top right: main slope with (b) alluvial talus material at toe and (c) vegetated slope. Right: northeast limit of property and slope with (a) exposed limestone bedrock at base of slope.

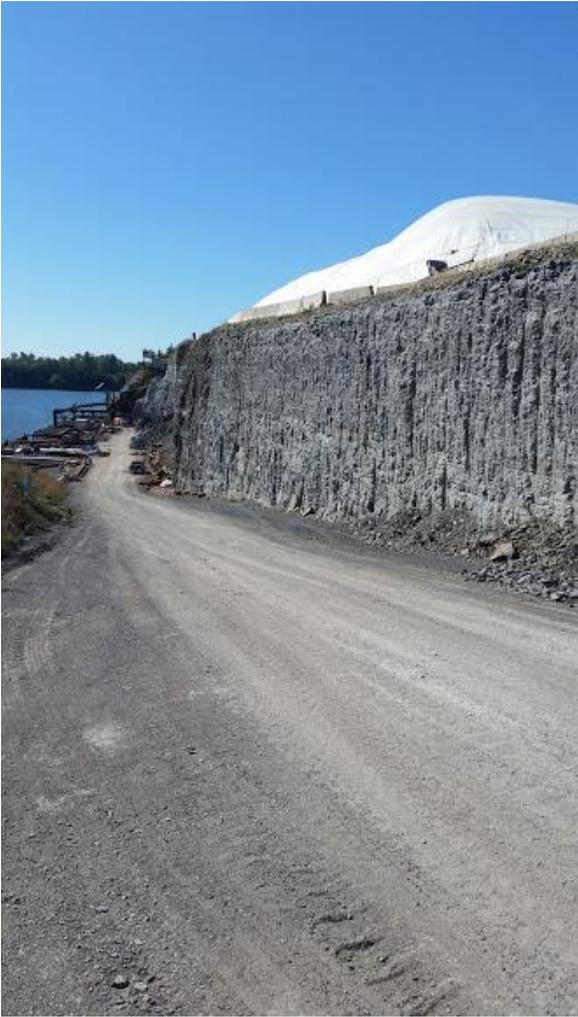
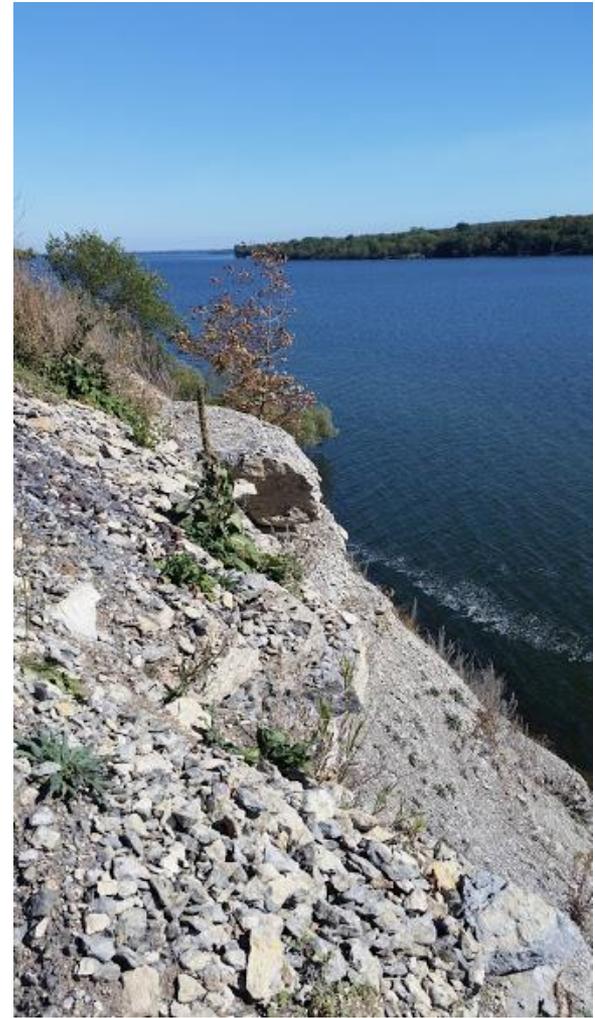
Left: existing cut slope on north side of ramp. Right: view of slope looking NE from the top of slope near the top of ramp
