## BIENNIAL OSIM BRIDGE INSPECTION & CAPITAL NEED ANALYSIS

### SUMMARY REPORT

**TSI PROJECT NO: 24079**

**GANANOQUE**

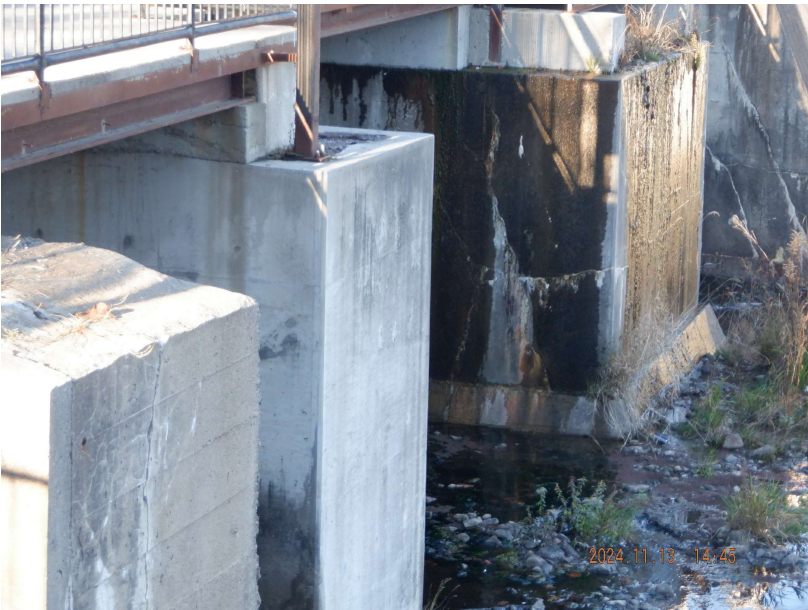
Figure 18 : Dam Sluits (Typ.)-Evidence of Wide Crack with Efflorescence

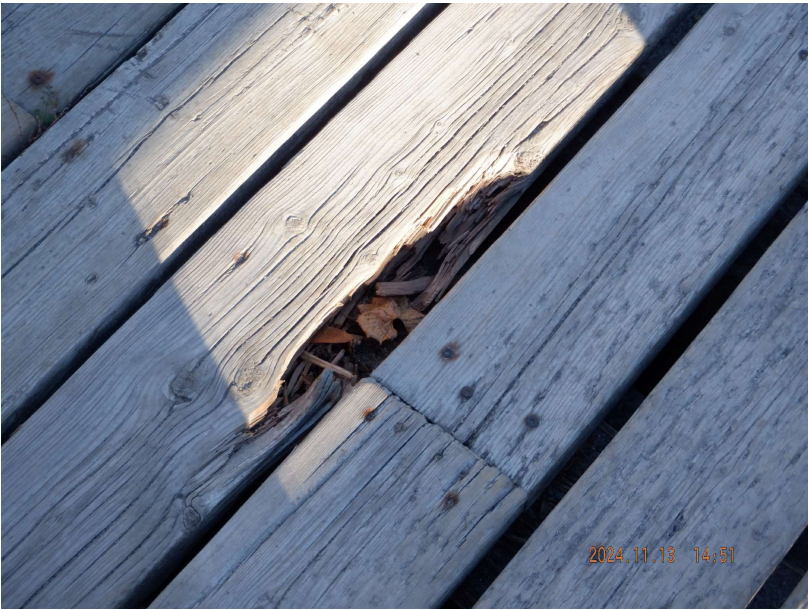
Figure 13 : Bridge Deck-Evidence of Medium Rot

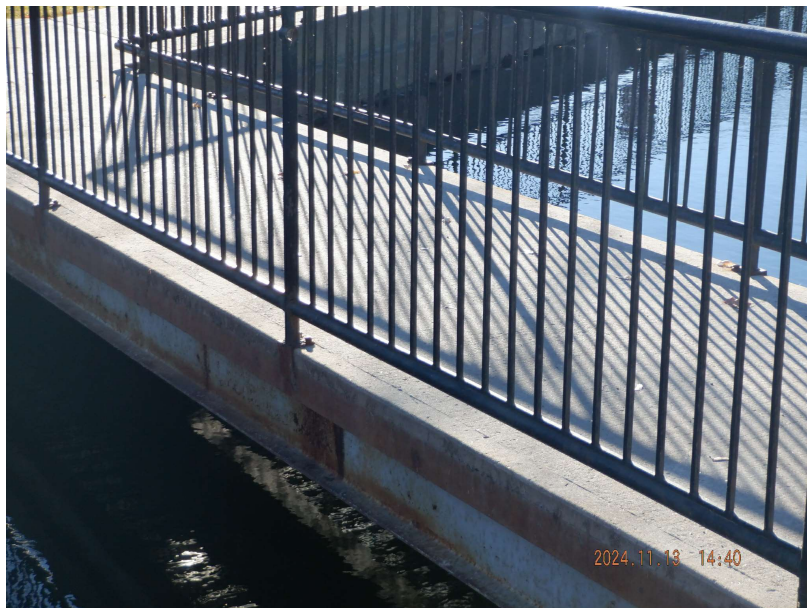
Figure 10 : Exterior Railing & Fascia-Evidence of Medium Rust

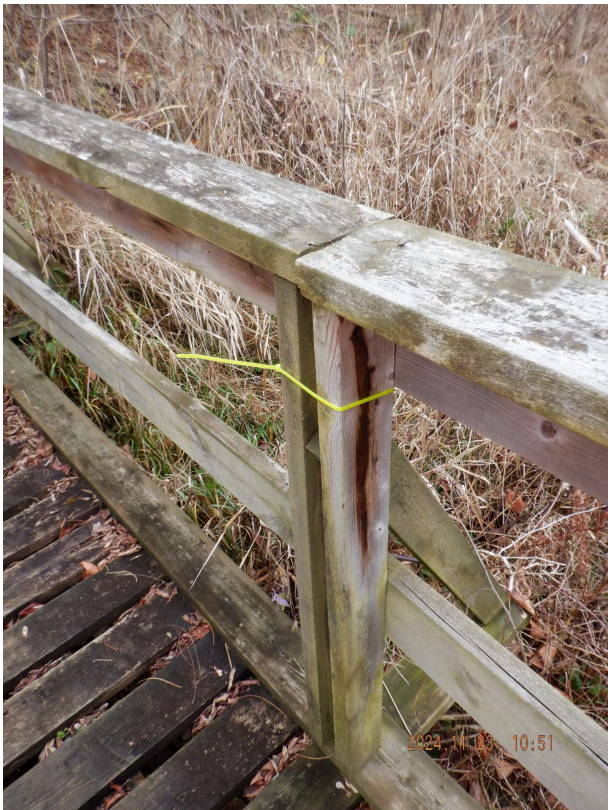
Figure 10 : Bridge Railing-Evidence of Loose Connection

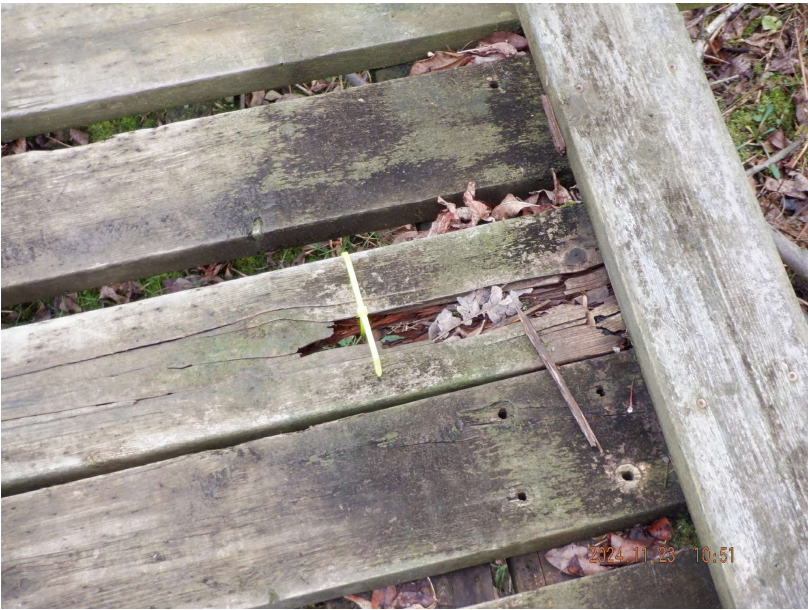
Figure 11 : Bridge Deck-Broken Plank

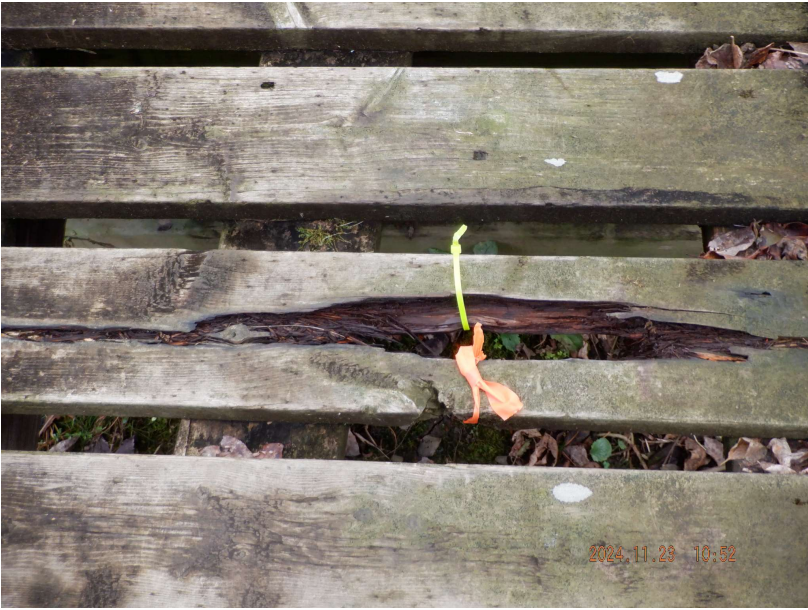
Figure 12 : Bridge Deck-Broken Plank

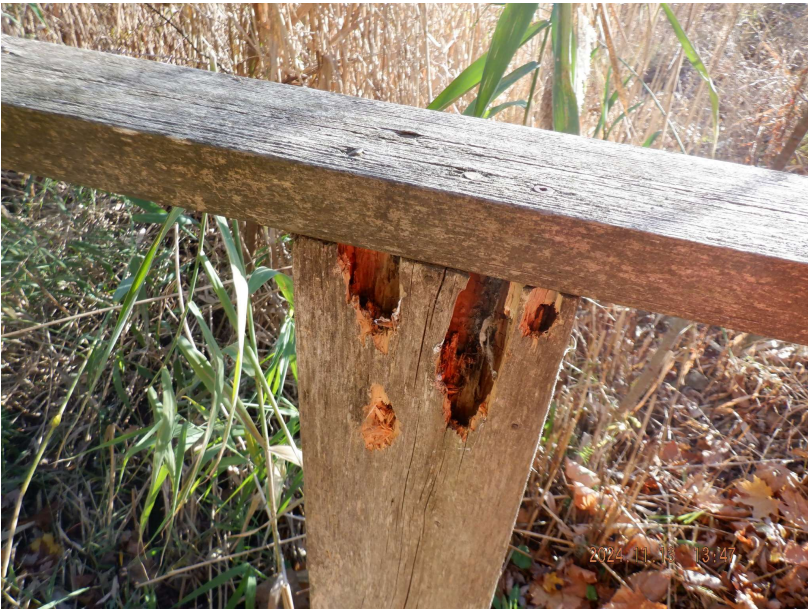
Figure 9 : Railing-Evidence of Severe Rot

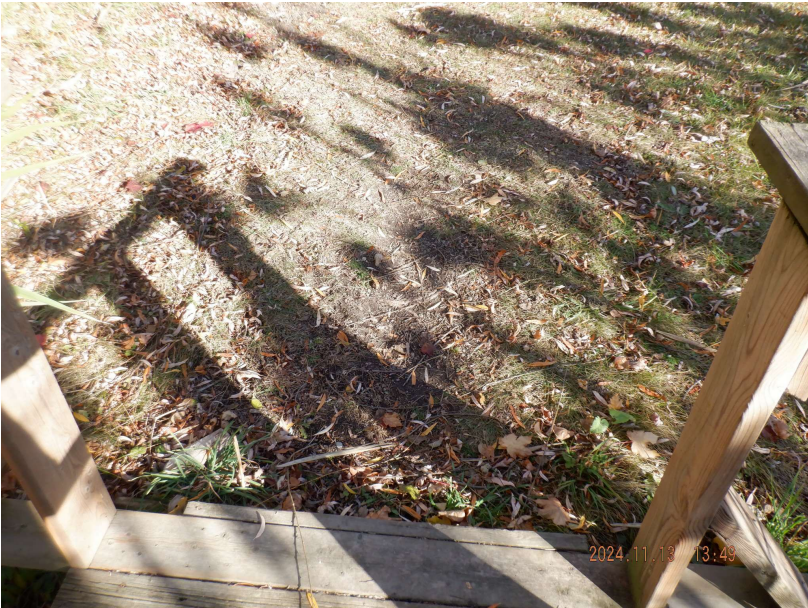
Figure 14 : East Approach-Evidence of Tripping Hazard

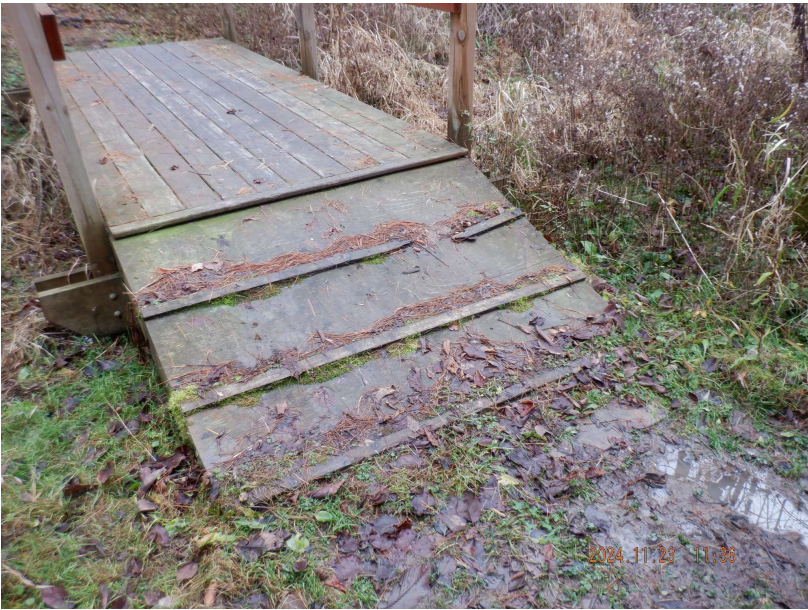
Figure 5 : South Ramp-Evidence of Broken Timber & Localized Failure of Ramp Ribs
