893 & 911 LOCKHART STREET, INNISFIL RESIDENTIAL DEVELOPMENT

TREE INVENTORY, ANALYSIS, AND PRESERVATION REPORT

JULY 2020

OUR FILE: LA 408-19

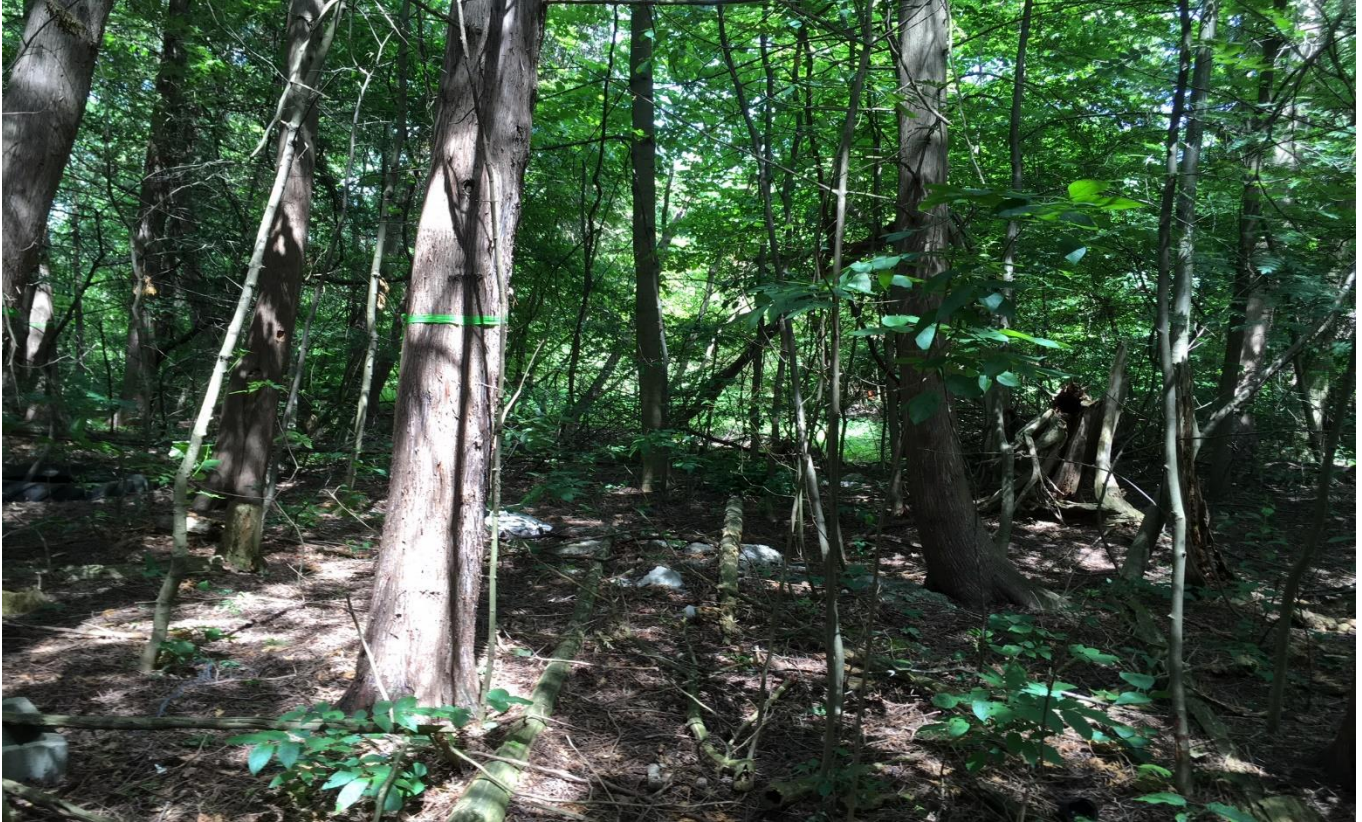
This section tree species was observed to be dominated with Eastern White Cedar, with Norway Maples consistently along the west boundary and a few Black Walnut trees surrounding the 2 existing buildings within this section. Of the eighty (**80**) trees within this Section, most of the trees are mature, with a few younger trees along the western boundary. The average diameter at breast height (dbh) is greater than 30cm. A typical view of the section can be seen in **Photo A, Appendix D**.

Section 2 is located adjacent to Section 1, and includes a small section of fenceline along the southern boundary. LEGroup staff observed seventy-seven (77) trees, with the dominant tree species in this section being Eastern White Cedar, and there was a significant change in canopy elevation at the northeast side of Section to a lower and considerably wetter area. Other trees within this Section included Norway Maple, Sugar Maple, White Ash, American Elm, and two (2) Wild Plum trees. All White Ash within this section show signs of the Emerald Ash Borer (EAB), and Riverbank Grape Vine is present in this Section, although to a lesser extent than other Sections. A typical view of this section can be seen in **Photo A, Appendix D**.

Photo A: Photo showing typical density within both Sections 1 and 2.

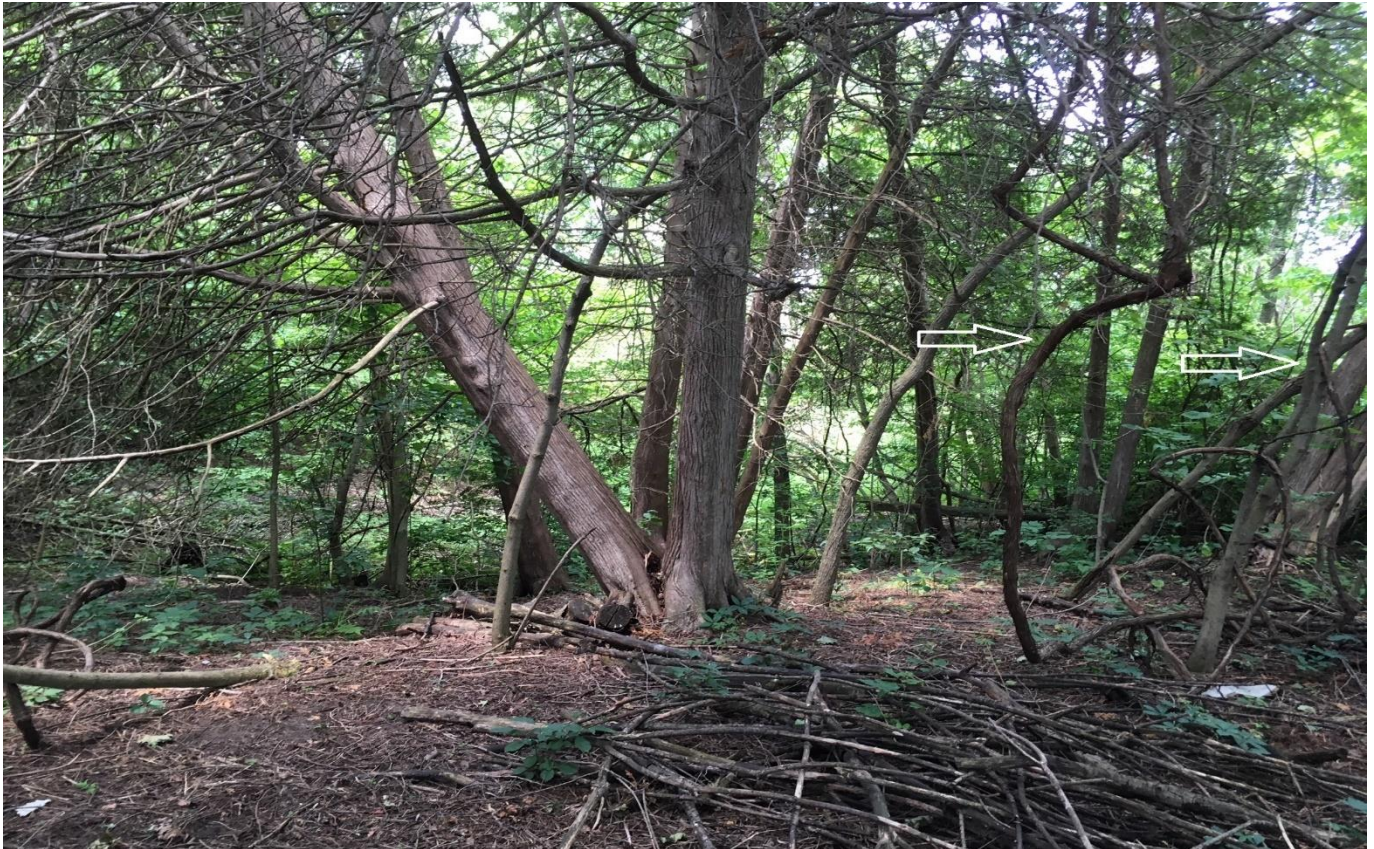
A total of 604 trees were observed at a dbh (diameter breast height) of equal to or greater than 10cm. on the subject site. LEGroup staff observed that the majority of trees on-site were in marginal to poor condition, largely due to the aggressive growth of the Riverbank Grape Vine throughout the site which has entered the canopies of most trees and is blocks sunlight from reaching the host tree (see **Photos B & D, Appendix D**).

This Section has a decrease in elevation, and is significantly wetter than other sections. While there were only fifteen (15) trees in this Section, they are all mature and fairly large with an average dbh of over 30cm. Norway Maple, White Ash and Yellow birch were found, all of which were in poor condition with the Ash showing signs of EAB. One large Black Walnut was found to be in fair condition, despite the trees nearby all having exposed roots in the extremely wet soil, and dense Riverbank Grape vines growing in their canopies. A typical view of this section can be seen in **Photo B, Appendix D**.

Photo B: Photo looking north at Section 2 showing a decrease of elevation into Section 3. Note Riverbank Grape.

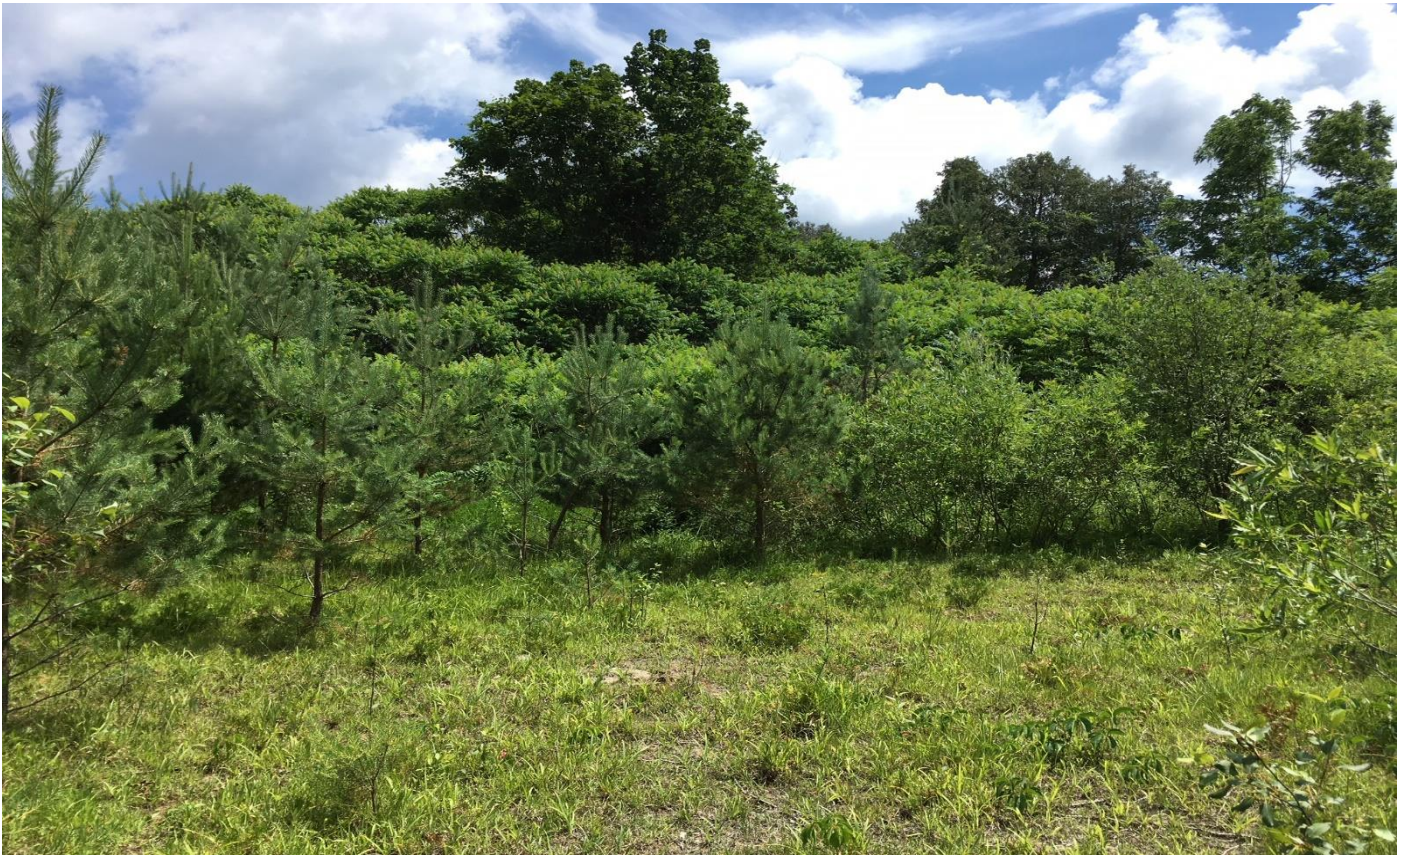
Photo C- Photo looking south at section 5.

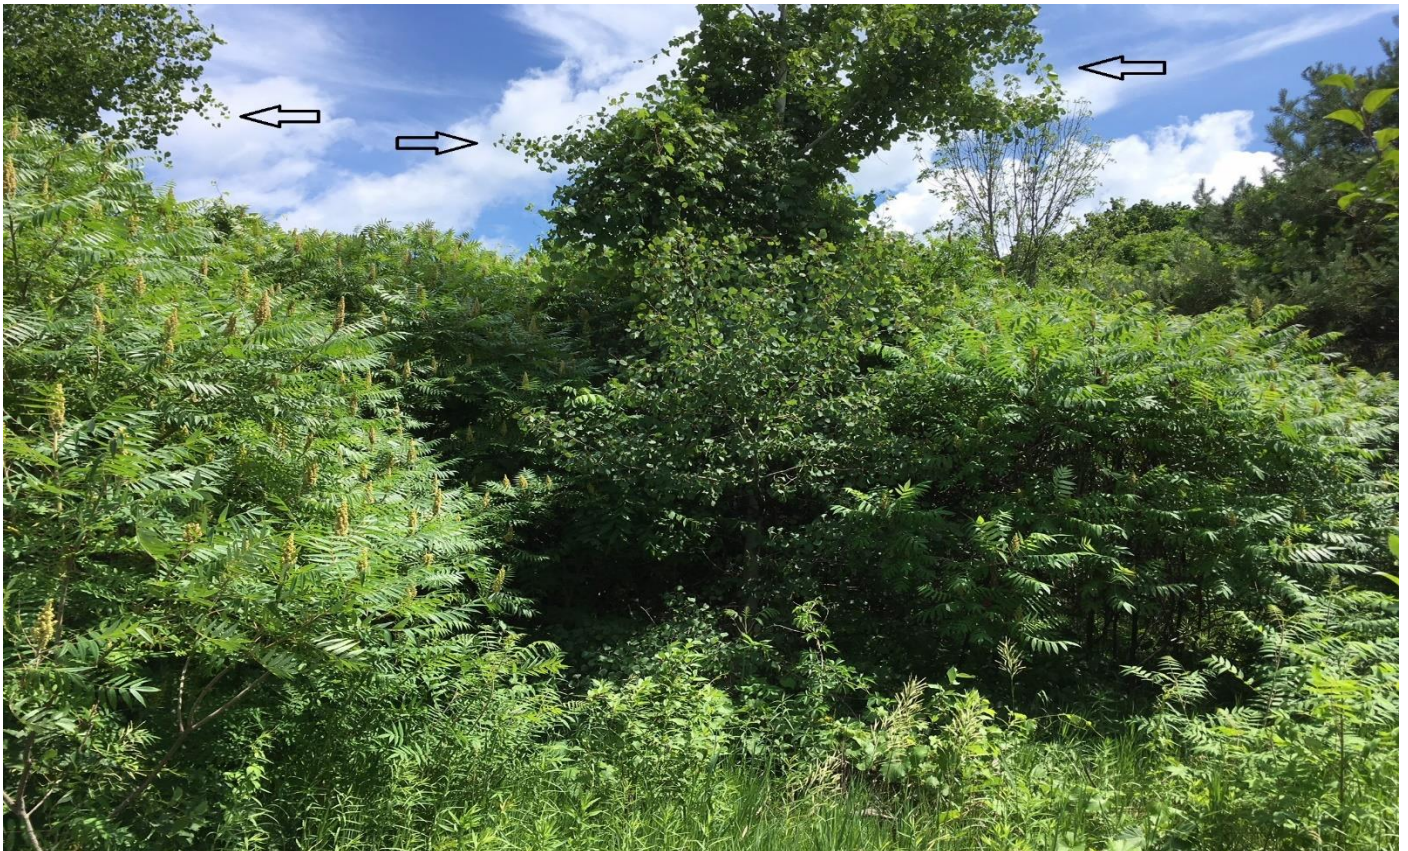
Photo D- Photo looking east at section 5. Note Riverbank Grape (arrows).
