PHASE ONE ENVIRONMENTAL SITE ASSESSMENT

893 AND 911 LOCKHART ROAD,
INNISFIL, ONTARIO

MMS LOCKHART HOLDINGS INC.

PROJECT NO.: 201-09744-00
DATE: DECEMBER 2020

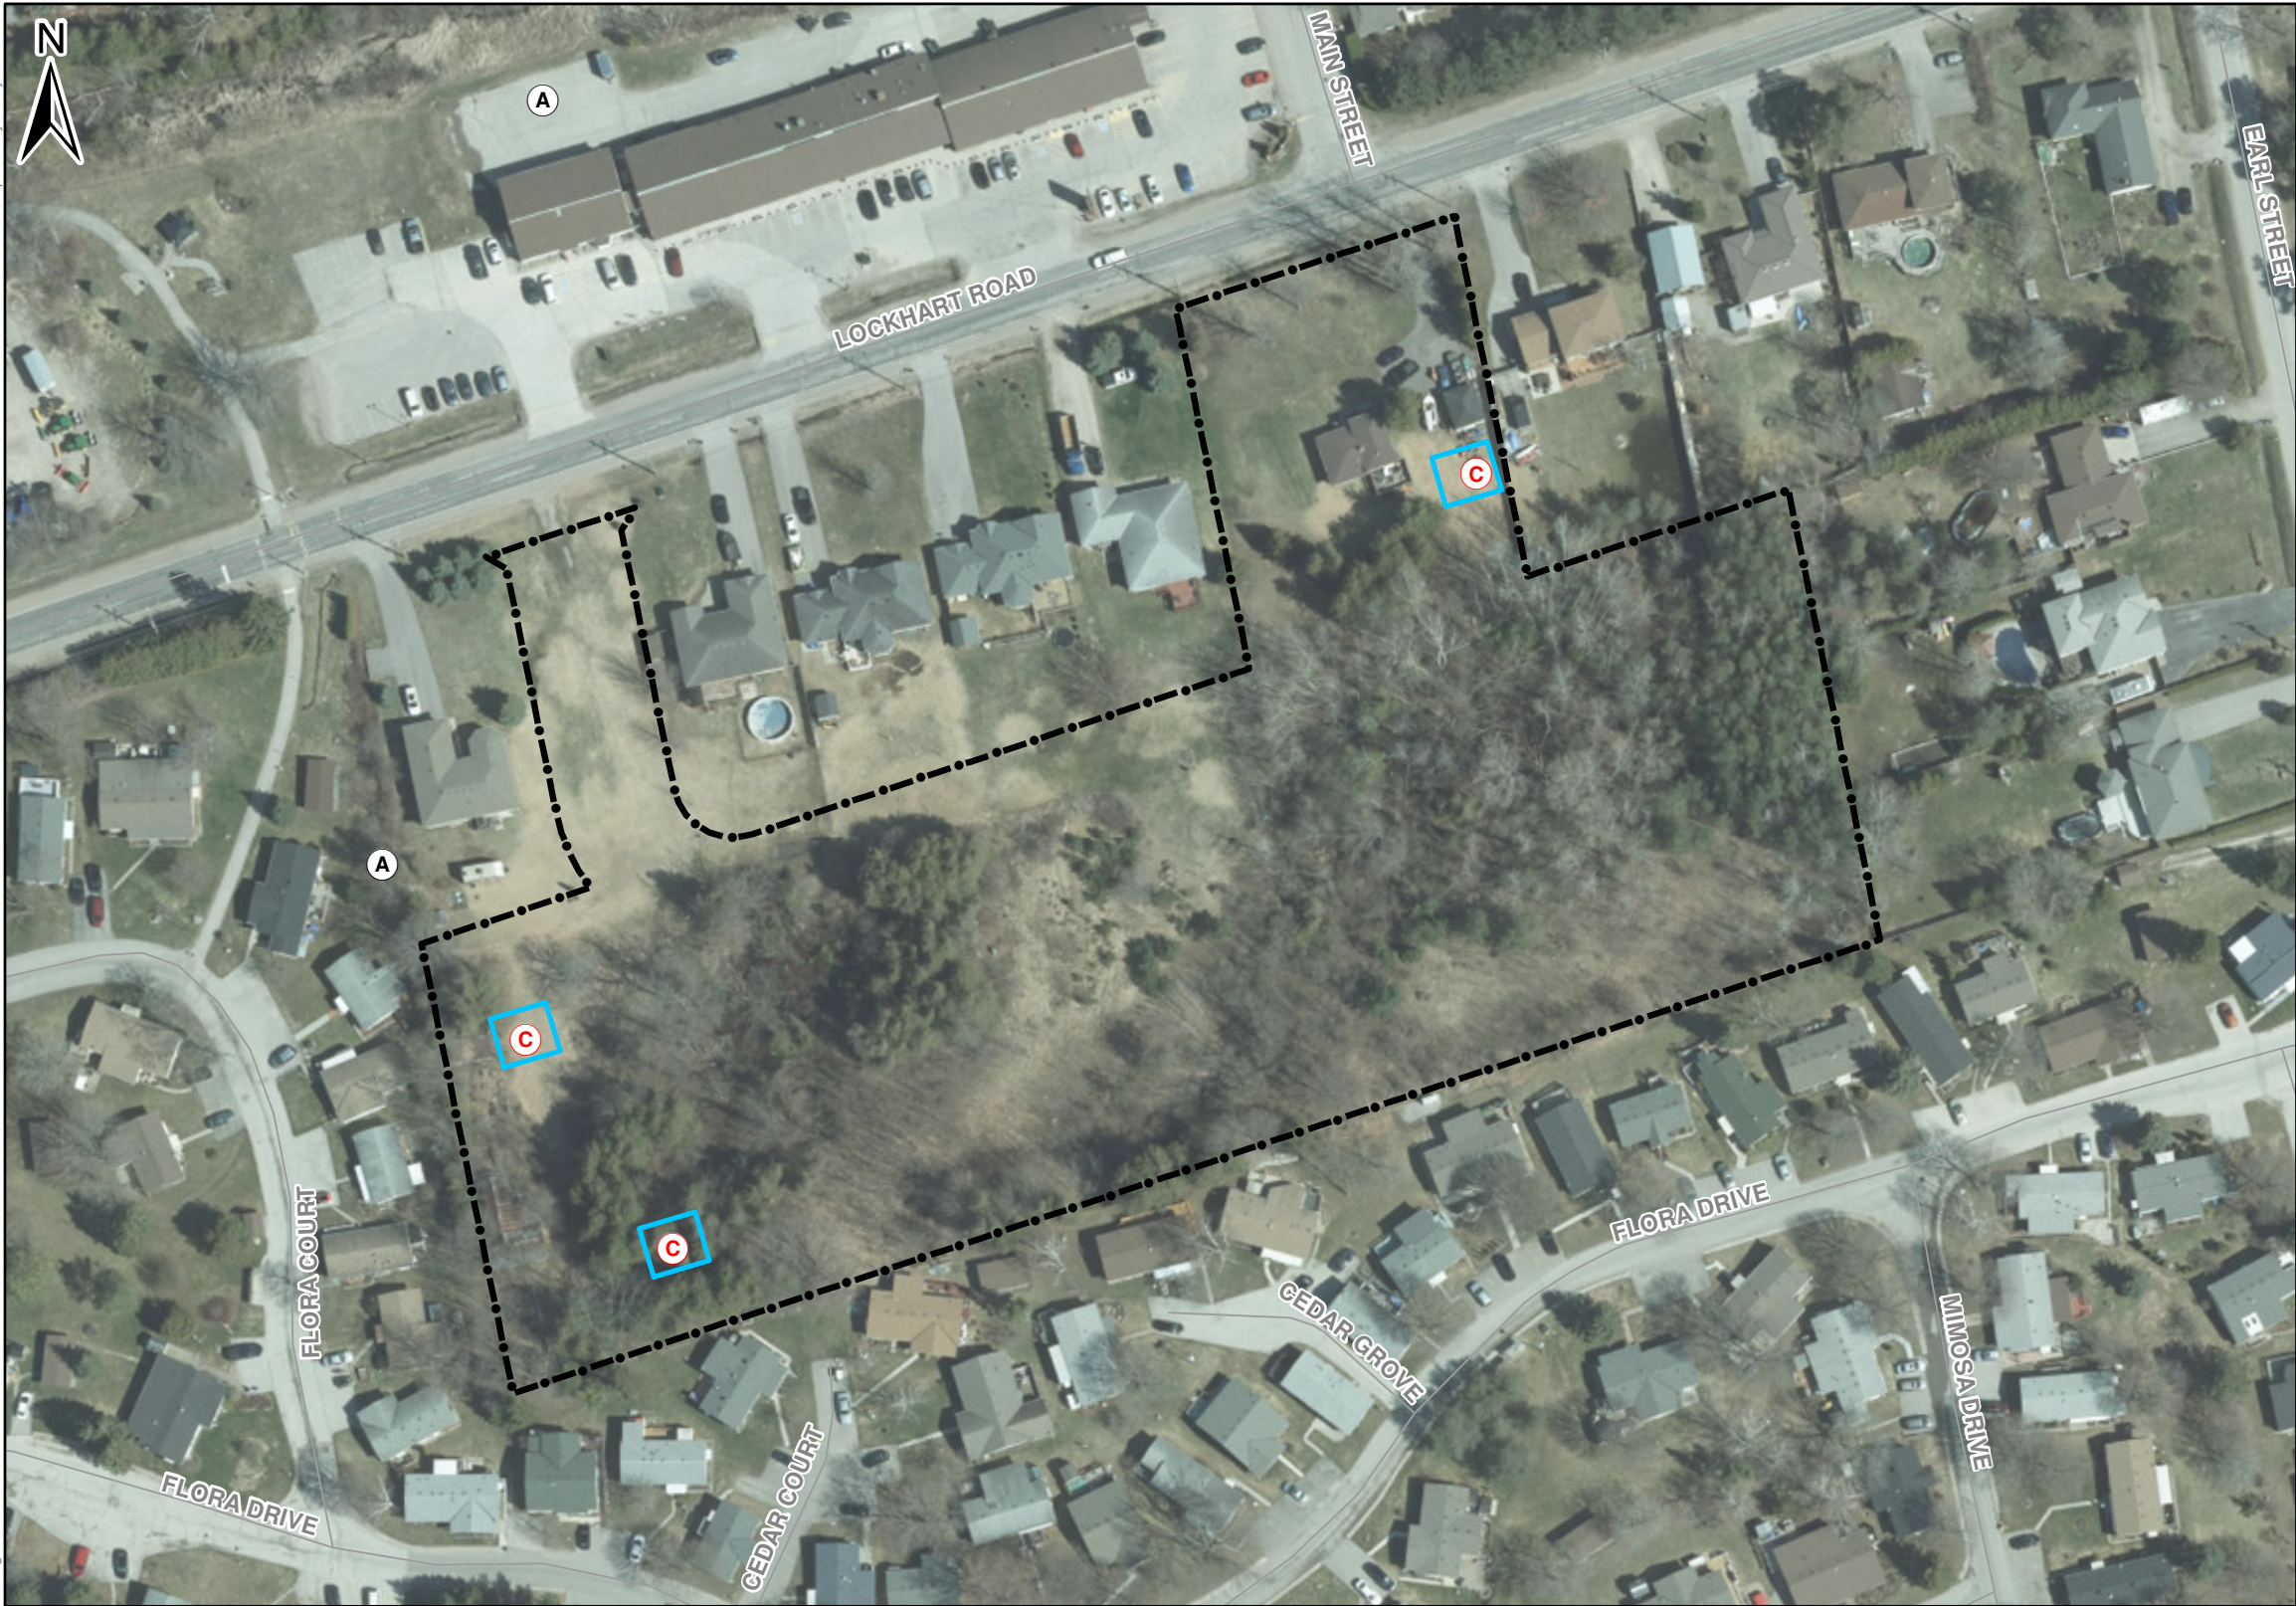
PROJECT NO.: 201-09744-00	REVIEWED BY: JD
	DATE: NOVEMBER 2020	FIGURE: 1

The generator address shown in Table 4.3 is a residential dwelling with a small detached garage and is shown as PCA “B” on *Figure 1*. It is likely that a small-scale business operation involving production of waste oils operated from this garage. The small scale of the business combined with the down-gradient location relative to the Phase One Property suggests that any spills or leaks of these wastes could not have impacted the Phase One Property. For these reasons, this PCA is not an APEC within the Phase One Property.

Sanitary sewage spills have the potential to cause an adverse effect, and for this reason these spills have been identified as PCA “A” on **Figure 1**. However, all of these spills occurred within the Sandycove Acres retirement community north of the Phase One Property and appear to have been cleaned up or addressed to the satisfaction of MECP. All seven spill locations are located at lower elevations relative to the Phase One Property. Even if the spills were not cleaned up properly, the probability of any impacts within the Phase One Property caused by these spills is low to non-existent.

PCA	Description
PCA “C” (Figure 1) — Storage of liquid waste outdoors over unprotected earth	This Phase One ESA Report documents the presence of three (3) liquid waste storage areas: (i) adjacent to a detached shed within #893, (ii) adjacent to an abandoned shed within #911, and (iii) inside an abandoned shed within #911. The potential for unreported leaks and spills within these storage areas to impact soil and groundwater should be investigated. The liquid waste and containers should be properly disposed in accordance with O. Reg. 347 (as amended).

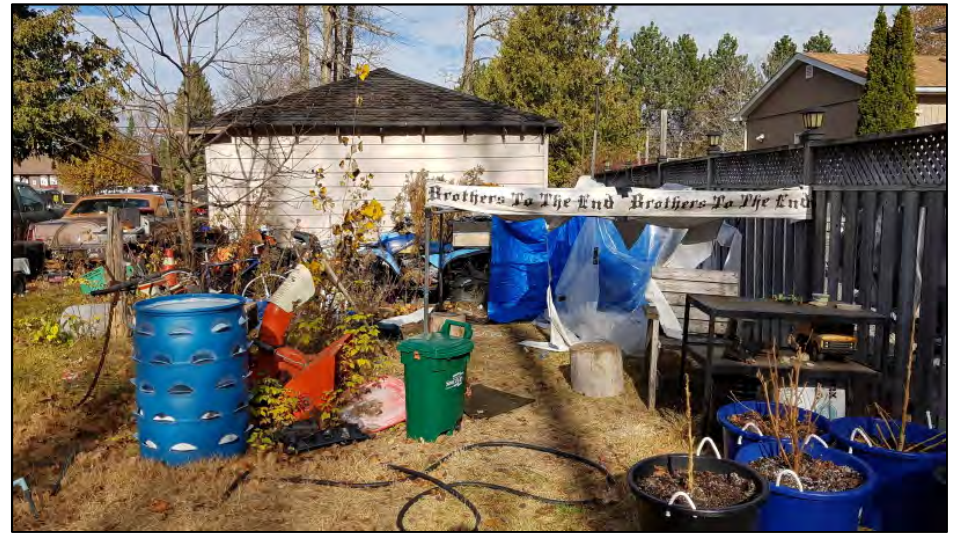
Photo B4: Rear of Detached Garage – 893 Lockhart Road.

Motorcycles and small utility vehicles (ATVs, lawn mowers) were observed at the rear of the detached garage (Photos B4 and B5). One unlabeled 205-litre steel drum was observed at the southwest corner of the garage (Photo B5). Based on answers to interview questions provided in Section 5.0 and based on the presence of several motorcycles, ATVs and lawn mowers near the shed it is possible that the drum contains waste fluids from small engine repair and maintenance operations. The drum was not located within a spill containment dike. Production and storage of waste engine fluids is a potentially-contaminating activity which is shown as "PCA-C" in **Figure 1**. Liquid waste within this drum and within any other containers within or adjacent to the detached garage should be properly disposed in accordance with O. Reg. 347 (as amended).

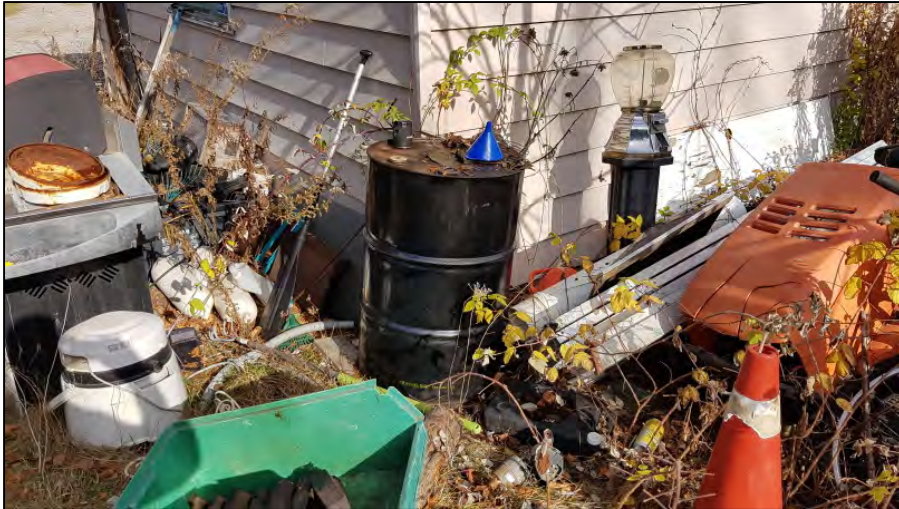
Photo B5: Liquid Waste Drum – Rear of Detached Garage – 893 Lockhart Road.

v. Details of potentially hazardous liquids or unidentified substances found at the property	An unlabeled 205-litre steel drum was observed at the southwest corner of the detached garage within #893 (Appendix B , Photo B5). This drum may contain waste fluids generated during repair and maintenance of small engines. Paint and solvent containers were also observed within or adjacent to abandoned storage sheds located within #911 (Appendix B , Photos B13, B17 and C18).

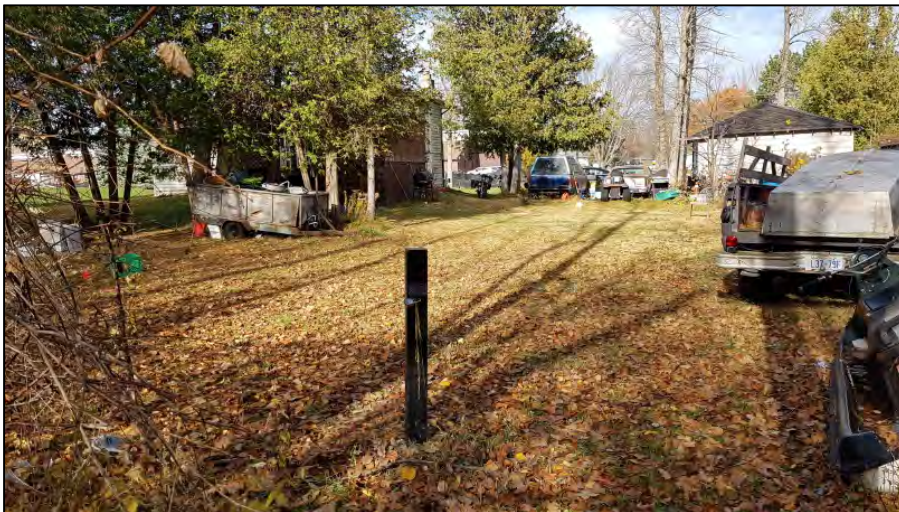
Photo B7: Groundwater-Monitoring Well – SE Corner of 893 Lockhart Road.

No evidence of fuel storage tanks was observed within #893. An inspection of the dwelling's perimeter revealed no evidence of former piping penetrations that might have suggested the presence of a former fuel oil heating tank. A groundwater-monitoring well set inside a monument-style casing was observed at the southeast corner of the #893 property (Photo B7). This well was one of four wells observed in the Phase One Property used for geotechnical and hydrogeological investigations conducted by another consultant as previously described.

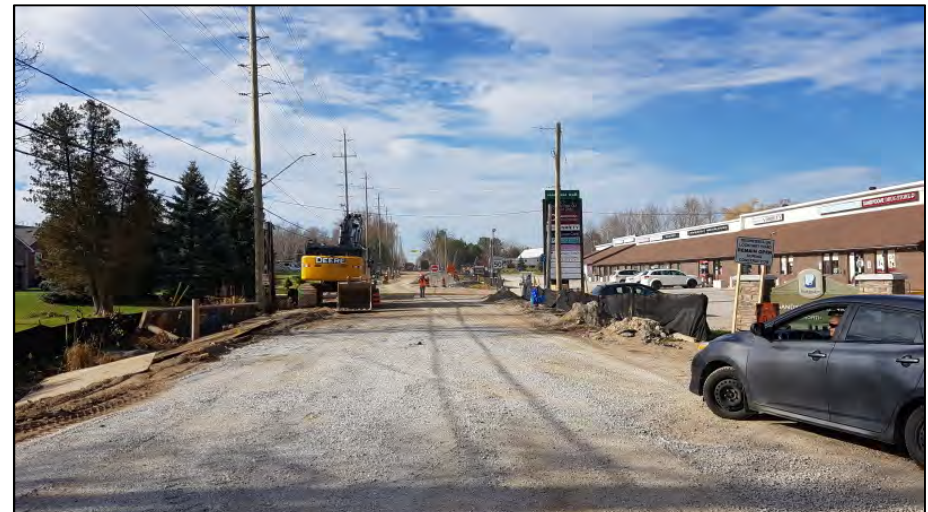
Photo B8: Looking West Along Lockhart Road From #893.

No potentially-contaminating activity was observed within the 250-metre Study Area. Reconstruction of Lockhart Road in front of the Phase One Property was underway at the time of the inspection (Photo B8). No significant risks such as temporary diesel fuel tanks for construction equipment were observed within the construction area. A small commercial strip-plaza containing various commercial uses was observed north of the Phase One Property (Photo B8). The Sandycove Acres retirement community is located north of the plaza and to the south of the Phase One Property (Photo B20). No evidence of fuel oil heating tanks was observed within the modular homes abutting the Phase One Property to the south while standing within the Phase One Property.

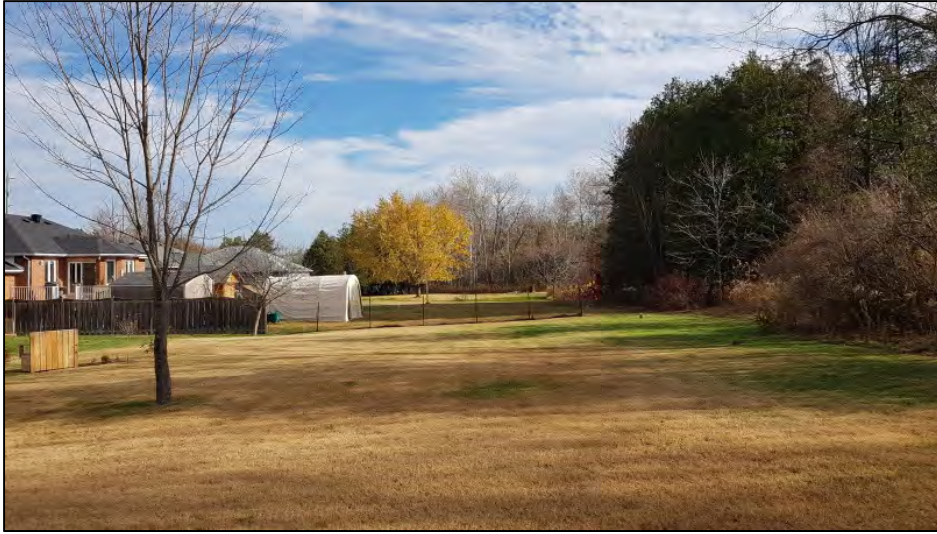
Photo B9: Looking East From #911 Lockhart Access.

A view facing east of the back-yards for dwellings located at #909, 905, 901, 897 and 893 Lockhart Road as observed from the #911 Lockhart Road access point is shown in Photo B9. A view facing west of the back-yard of the dwelling located at #913 Lockhart Road as observed from the #911 Lockhart Road access point is shown in Photo B10. No potentially-contaminating activity was observed within any of these properties.

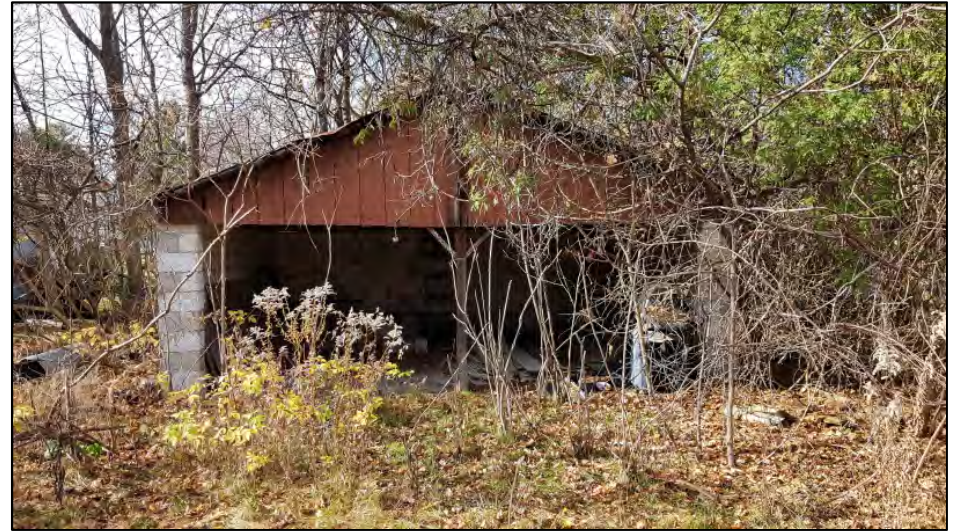
Photo B12: Abandoned Shed, NW Corner of #911 Lockhart Road..

One (1) abandoned barn and two (2) abandoned sheds were observed adjacent to the west property line of #911 Lockhart Road. Both sheds (Photos B12 and B16) contained paint and solvent containers (Photos B13, B17 and B18). The containers

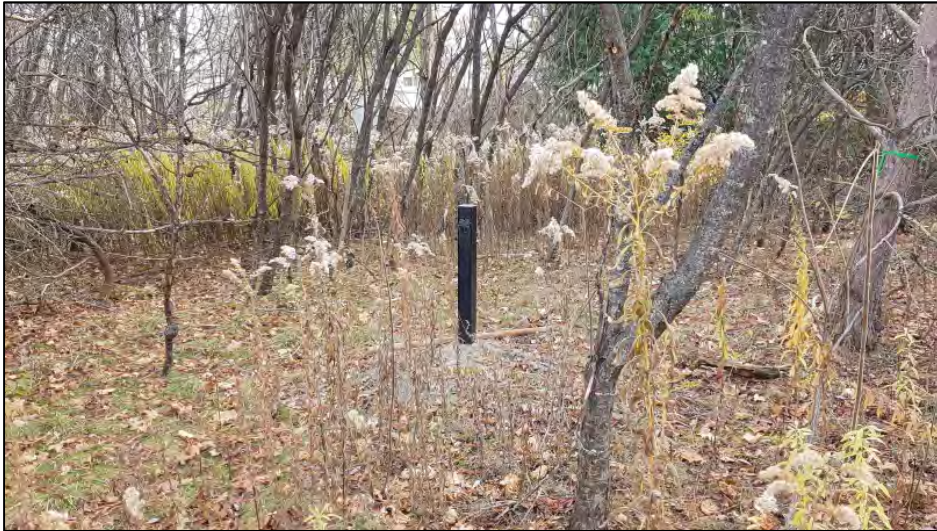
Photo B19: Groundwater-Monitoring Well, #911 Lockhart (#901 Visible in Rear).

A fourth groundwater-monitoring well installed by another consultant for geotechnical and hydrogeological investigations was observed near the south property line within #911 (Photo B19). The remainder of the #911 lands were covered by trees and dense vegetation.
