## Terms of Reference

Waste Collection  
Alternate Servicing Study

The District Municipality  
of Muskoka

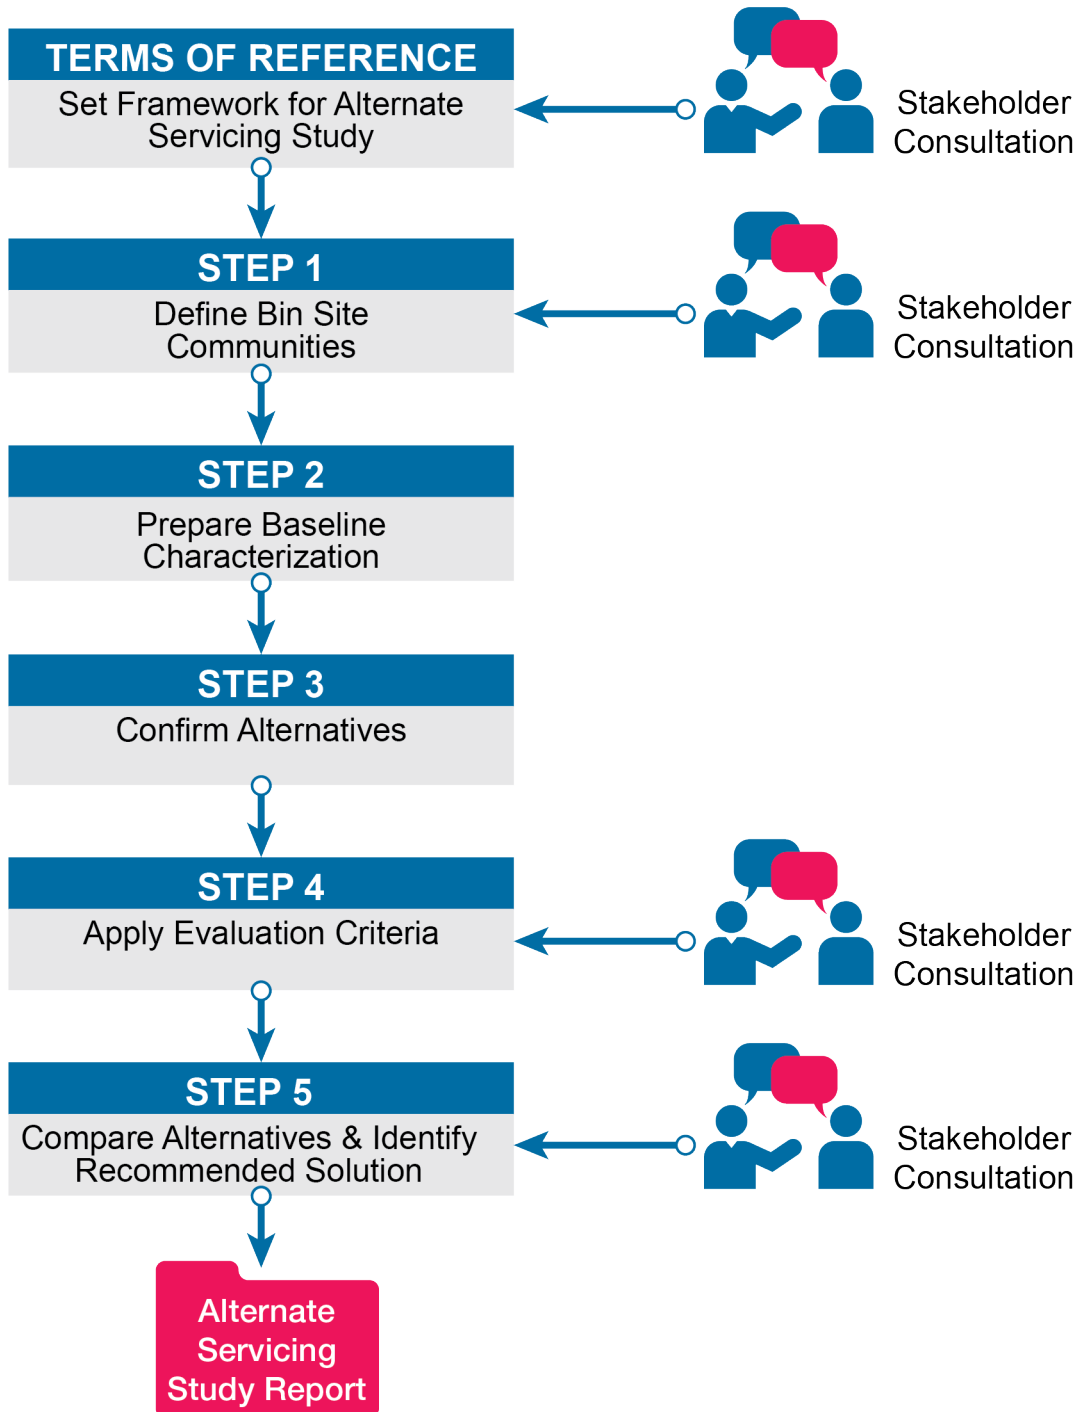
**Figure 5.1 Study Process**

These five steps and how stakeholder feedback will be incorporated into this process is shown in Figure 5.1. Further description of the proposed consultation plan is included in Section 6.

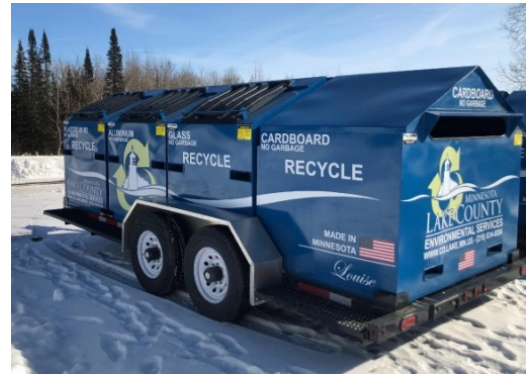
**Figure 5.2 Example Mobile Collection Trailer**

This alternative would involve converting existing bin site(s) to mobile bin sites through the use of special trailers or collection vehicles. An example of a mobile collection trailer is shown in **Figure 5.2**. Trailers would be parked at existing bin site location(s), supervised, and collected by the District on a predetermined schedule. Since this type of collection method is not widely used for long term waste collection in Ontario, it would require further consultation with the MECP to discuss approvability, and ensure it can be undertaken in the way that is protective of the natural environment.
