# Erosion Hazard Assessment Picton Terminal Picton, Ontario

Cambium Reference No.: 6824-001

October 17, 2017

Prepared for: G.D. Jewel Engineering

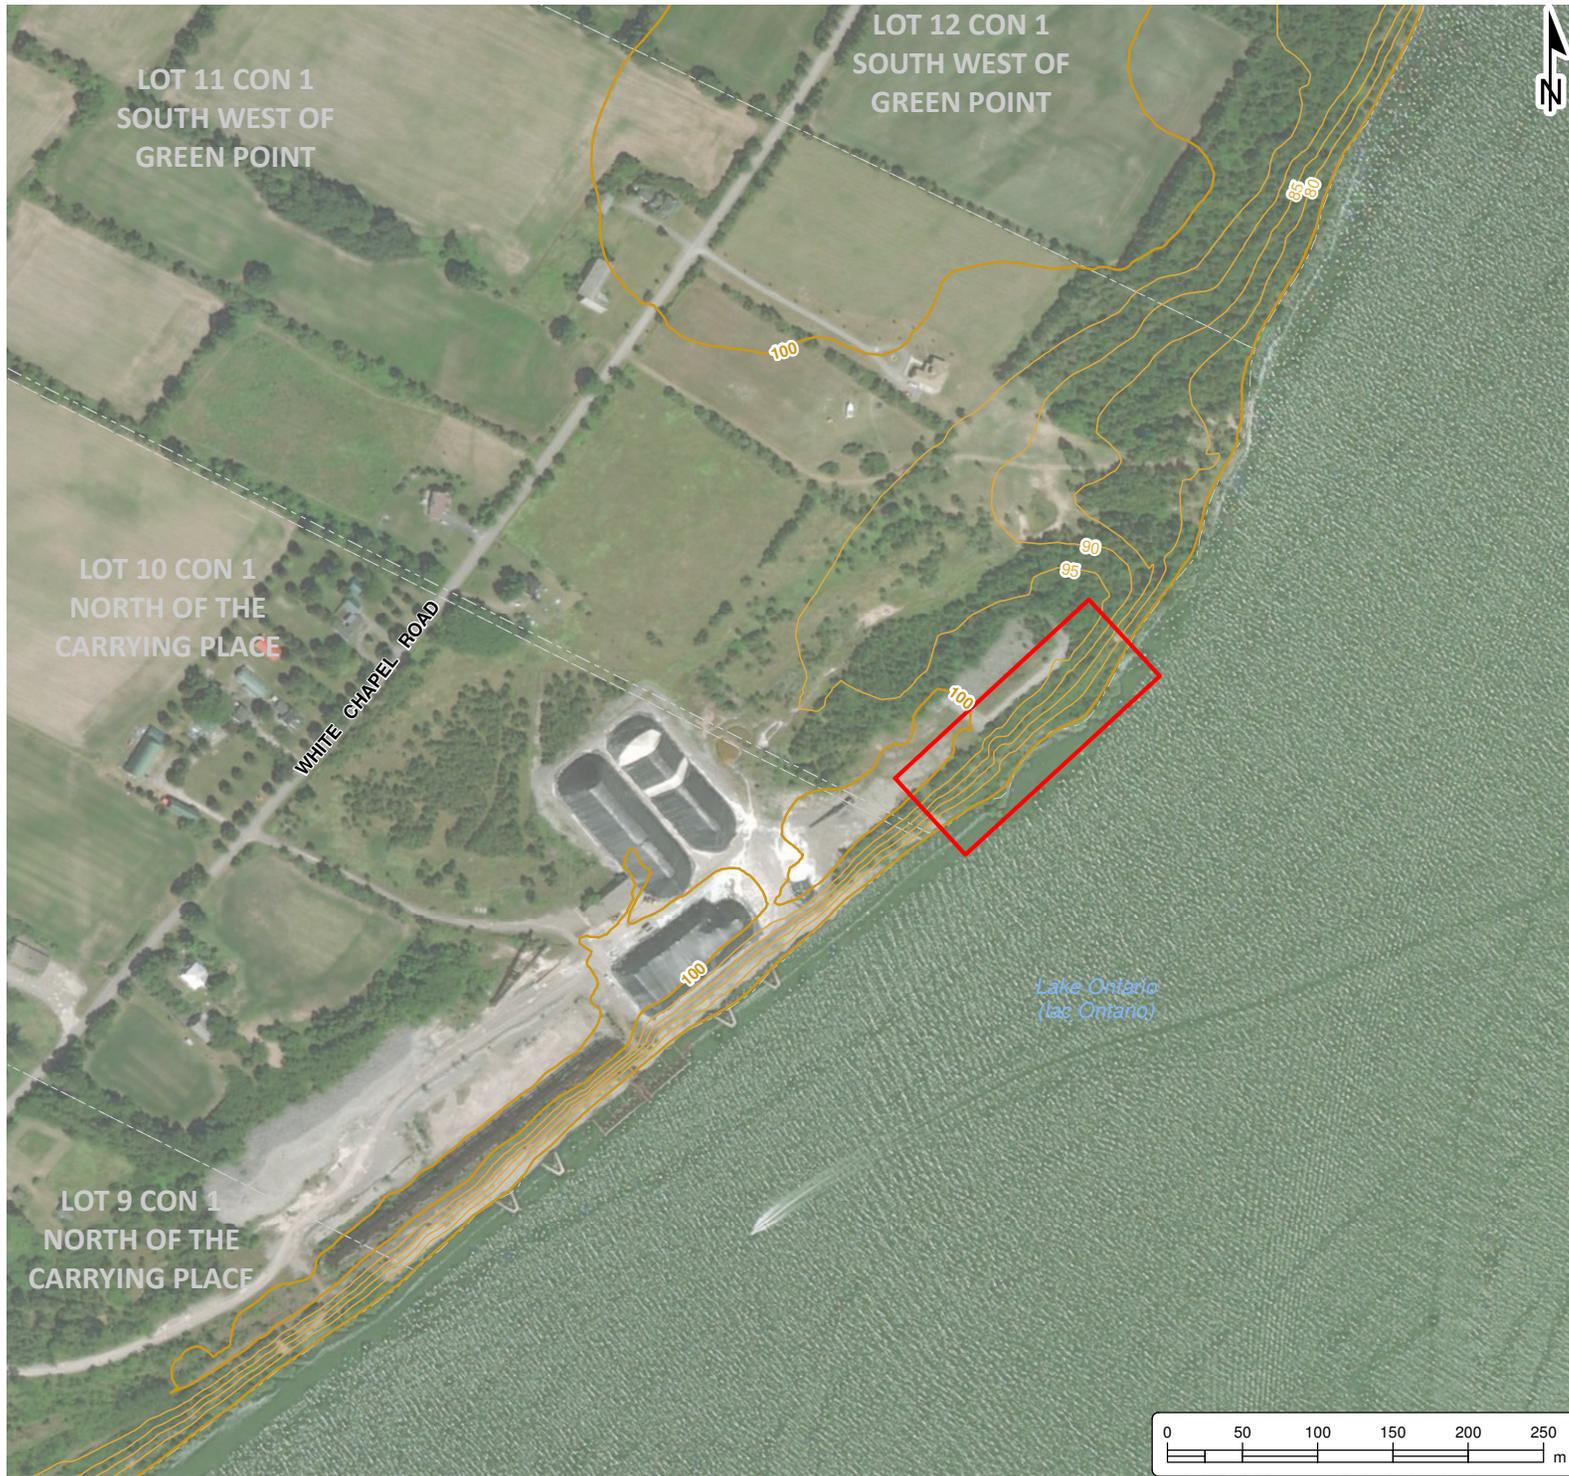
**EROSION HAZARD LIMIT**

The erosion hazard limit is defined as the sum of the stable slope allowance (0.75H:1V) and the toe erosion allowance (3 m), plus an additional 15m buffer, as per Section 2.1.a. of O. Reg. 319/09: Quinte Conservation Authority: Regulation of Development, Interference with Wetlands and Alterations to Shorelines and Watercourses. Items 2.1.a.i and 2.1.a.iii of O.Reg. 3.9/09 were found to have negligible impact on this site and have thus been excluded from the study. However, all distances are measured from 75.9 masl, the 100 year flood level of the area.
