## BIENNIAL OSIM BRIDGE INSPECTION & CAPITAL NEED ANALYSIS

### SUMMARY REPORT

**TSI PROJECT NO: 24079**

**GANANOQUE**

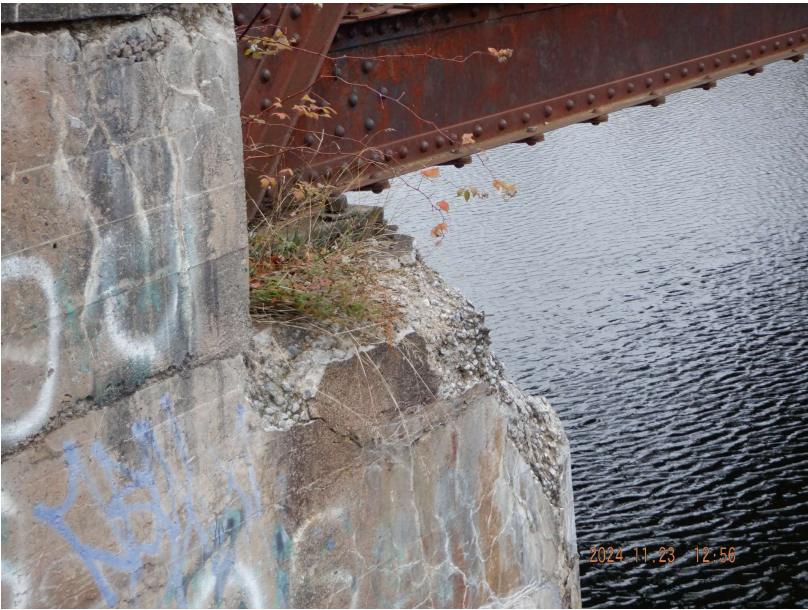
Figure 11 : Bridge Bearing Seat (Typ.)-Evidence of Severe Disintegration

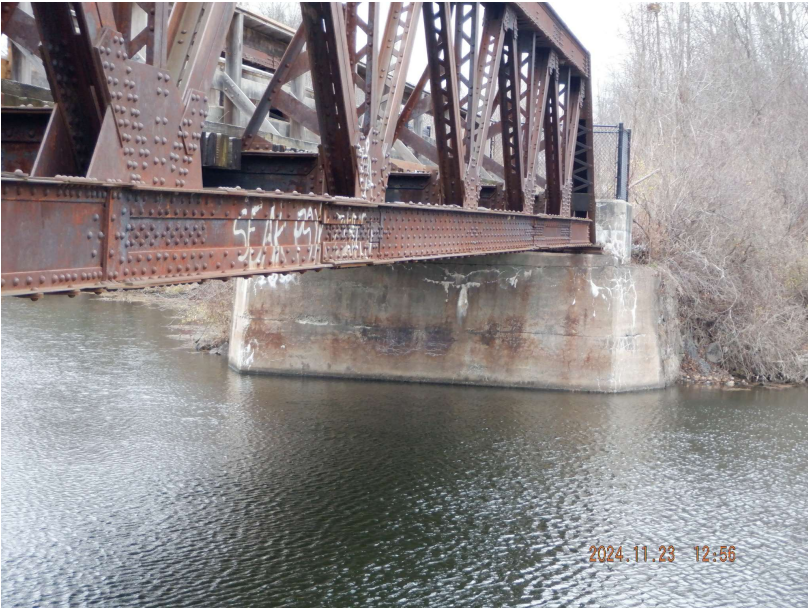
Figure 12 : North Abutment (Typ.)

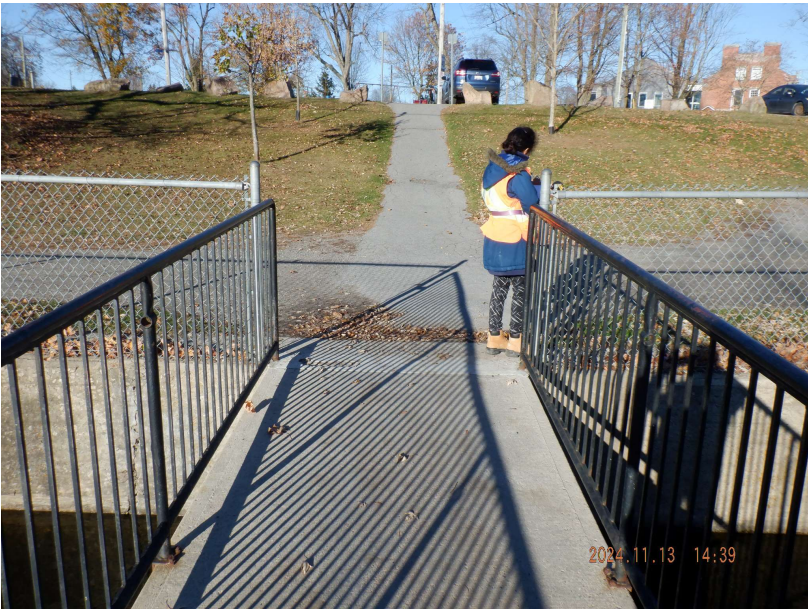
Figure 3 : Bridge Looking North

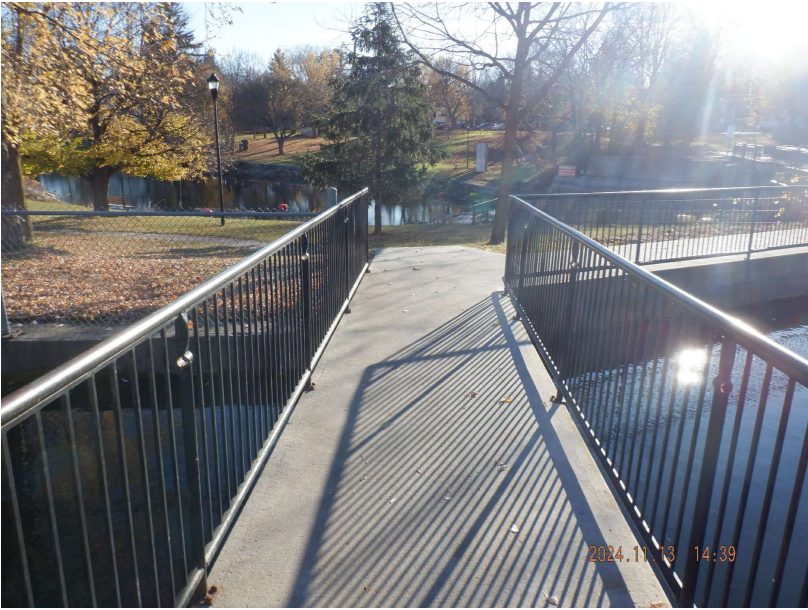
Figure 4 : Bridge Looking South

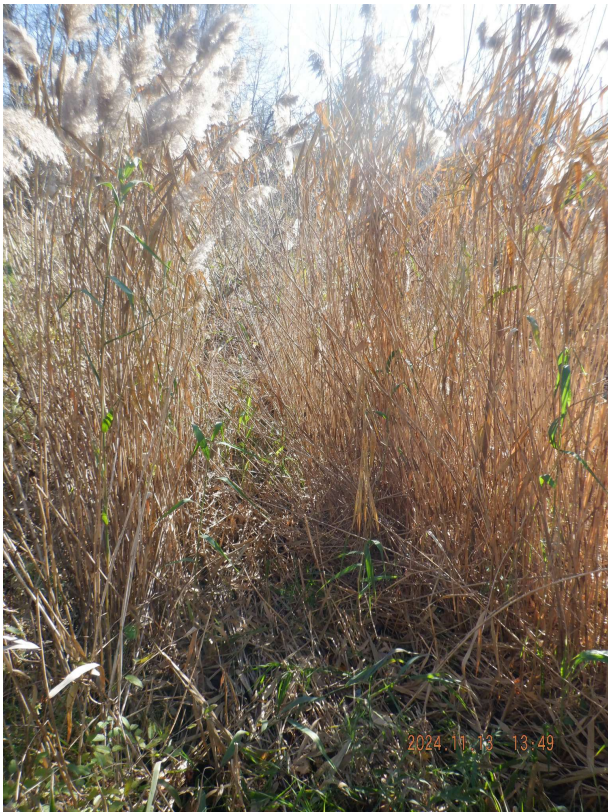
Figure 6 : Stream Looking South (D/S)-Evidence of Heavy Vegetation

<table><tr> <th colspan="3">Priority</th> </tr><tr> <td><b>Overall Comments:</b></td> <td colspan="4">Structure is generally in good condition. Evidence of localized severe rot on railing and weathering on soffit was noted. Maintenance need is recommended to remove heavy vegetation.</td> </tr></table>

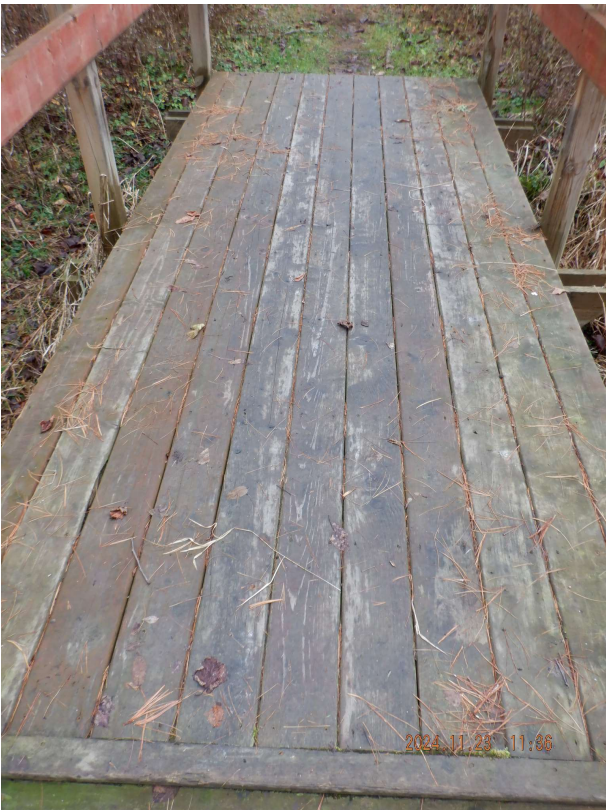
Figure 6 : Bridge Deck (Typ.)
