## BIENNIAL OSIM BRIDGE INSPECTION & CAPITAL NEED ANALYSIS

### SUMMARY REPORT

**TSI PROJECT NO: 24079**

**GANANOQUE**

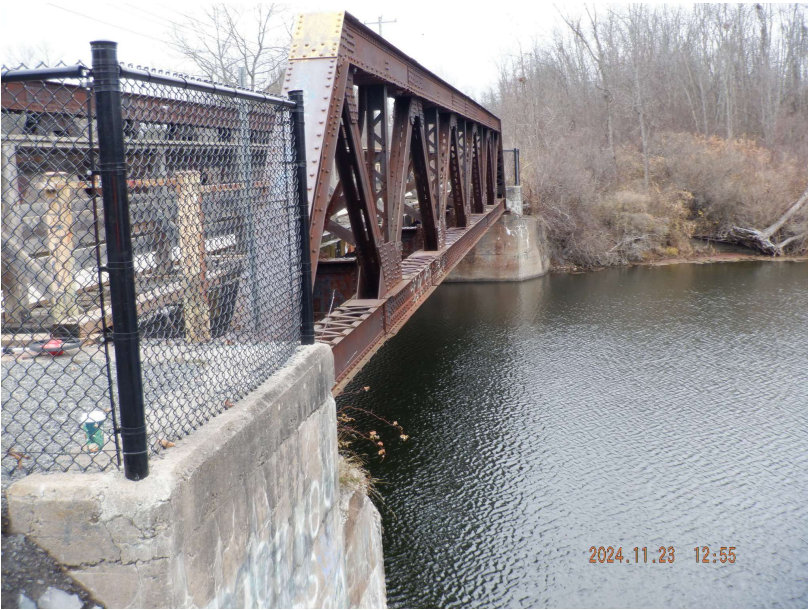
Figure 1 : West Elevation

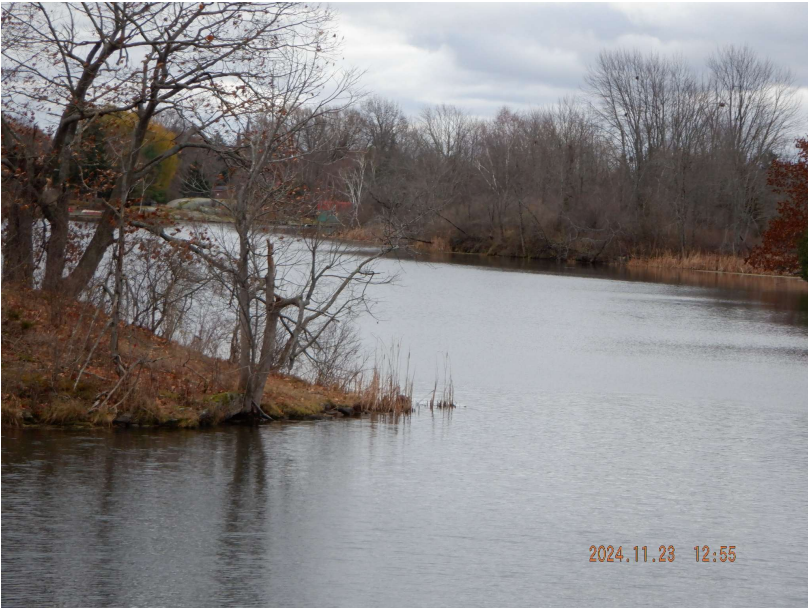
Figure 2 : Stream Looking East (D/S)

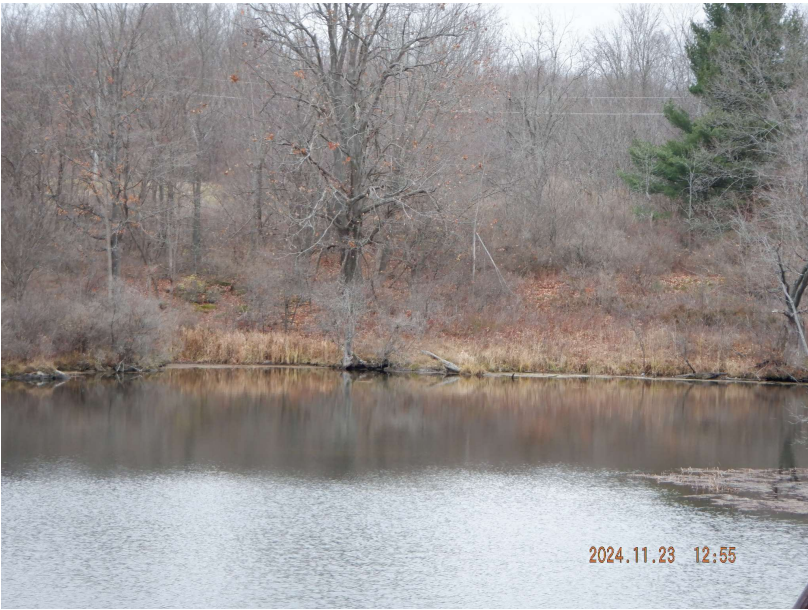
Figure 3 : Stream Looking West (U/S)

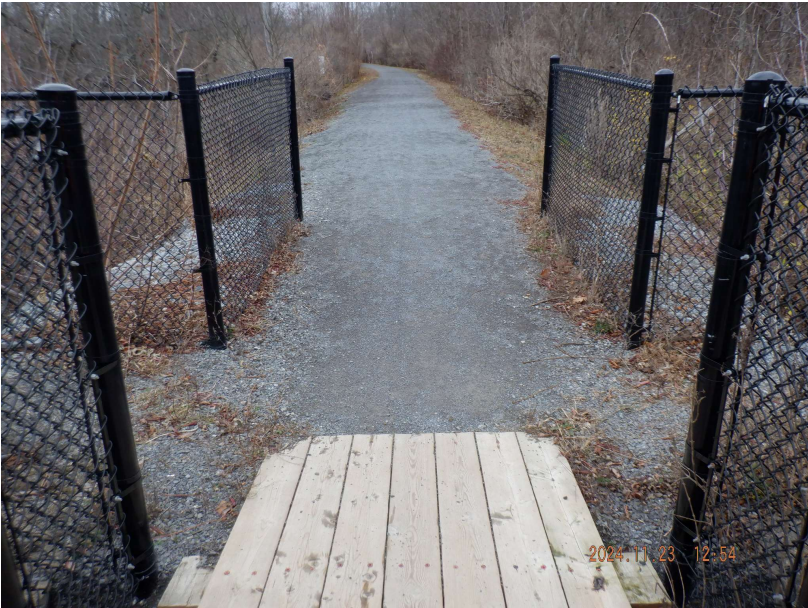
Figure 4 : North Approach

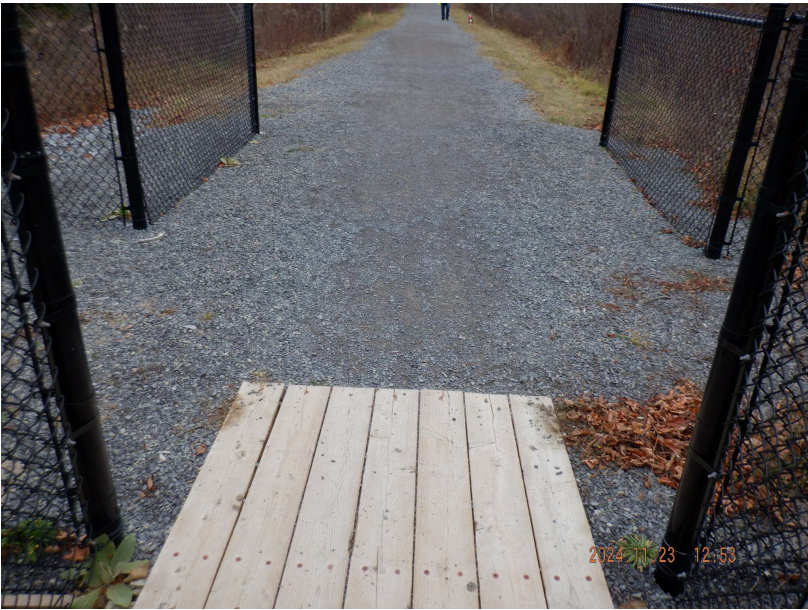
Figure 5 : South Approach

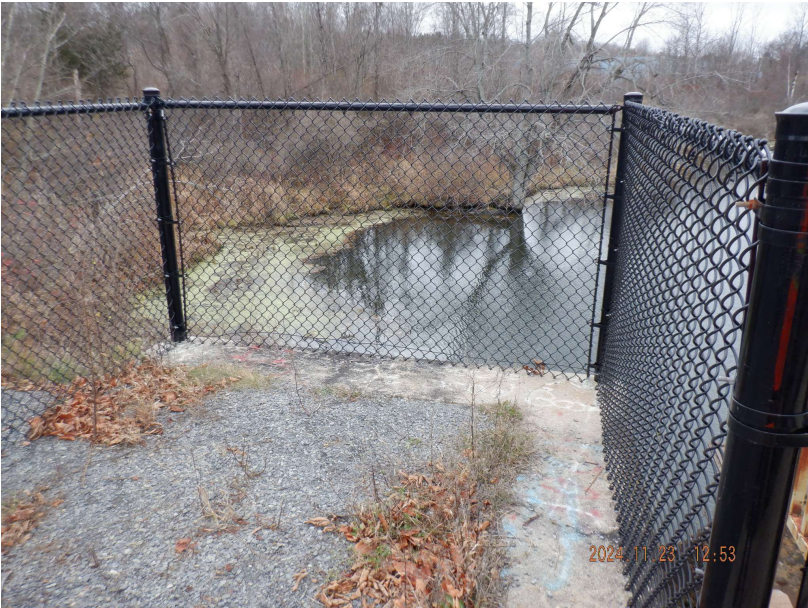
Figure 6 : Lookout Area (Typ.x4)

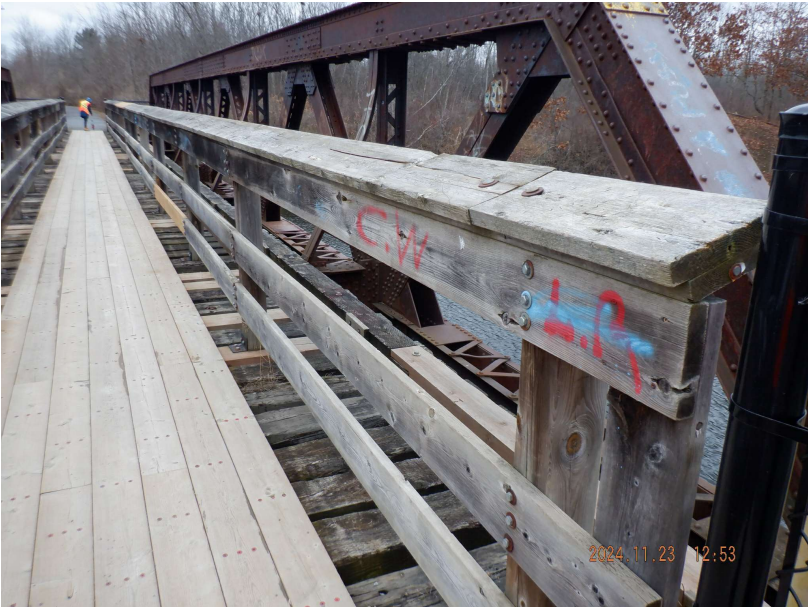
Figure 8 : East Railing (Typ.)

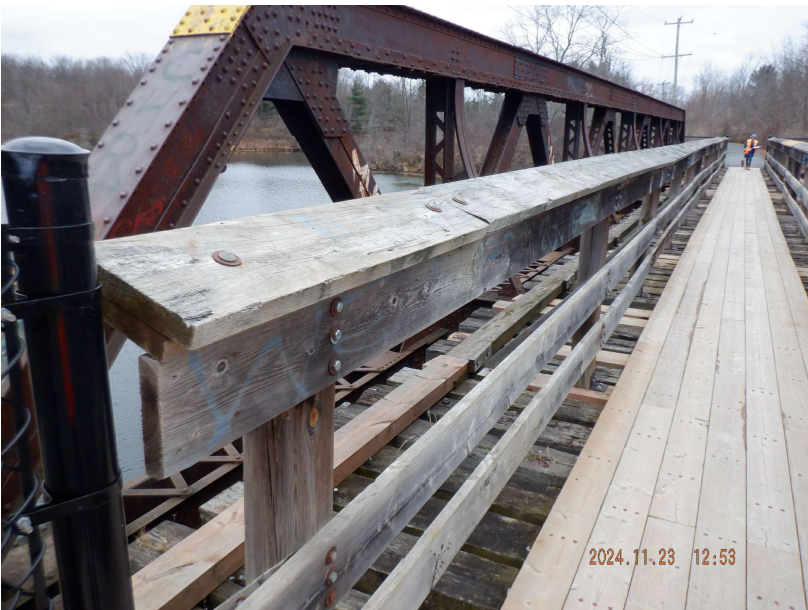
Figure 9 : West Railing (Typ.)

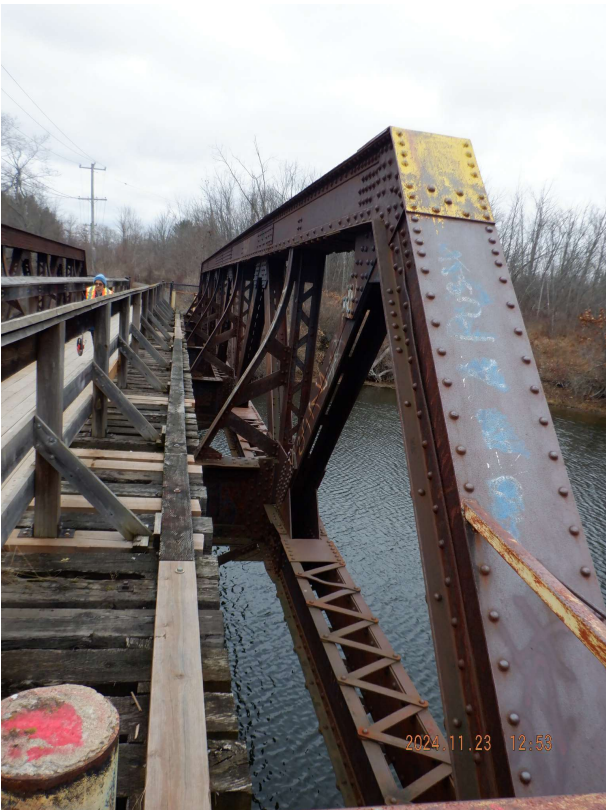
Figure 10 : Original Bridge Truss (Typ.)

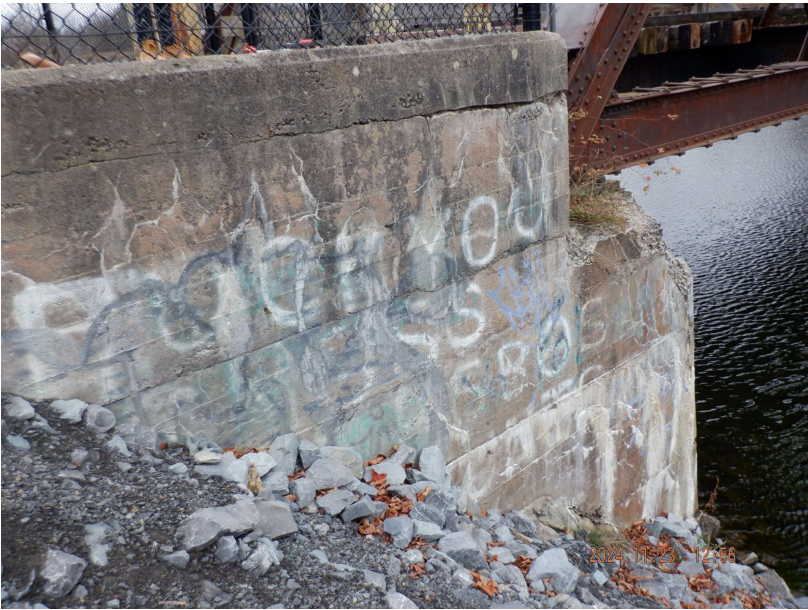
Figure 13 : SE Wingwall (Typ.)

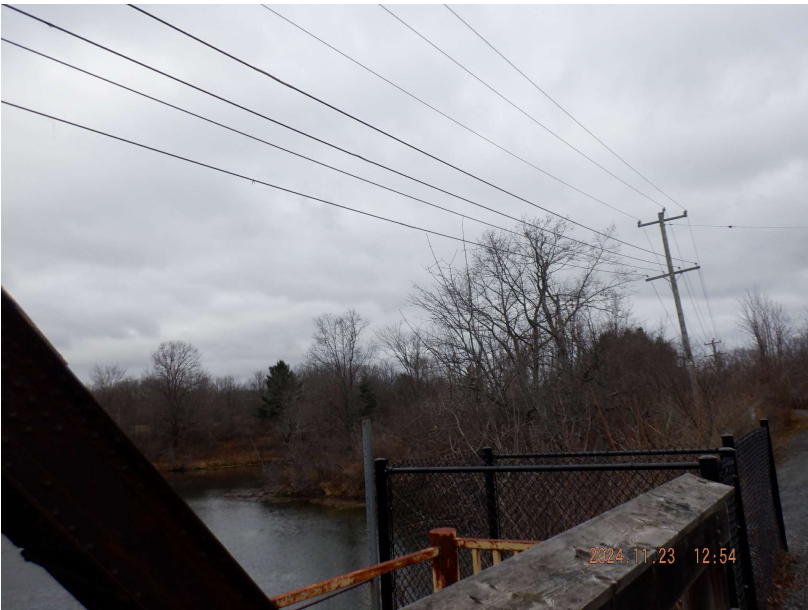
Figure 14 : Overhead Utility-West

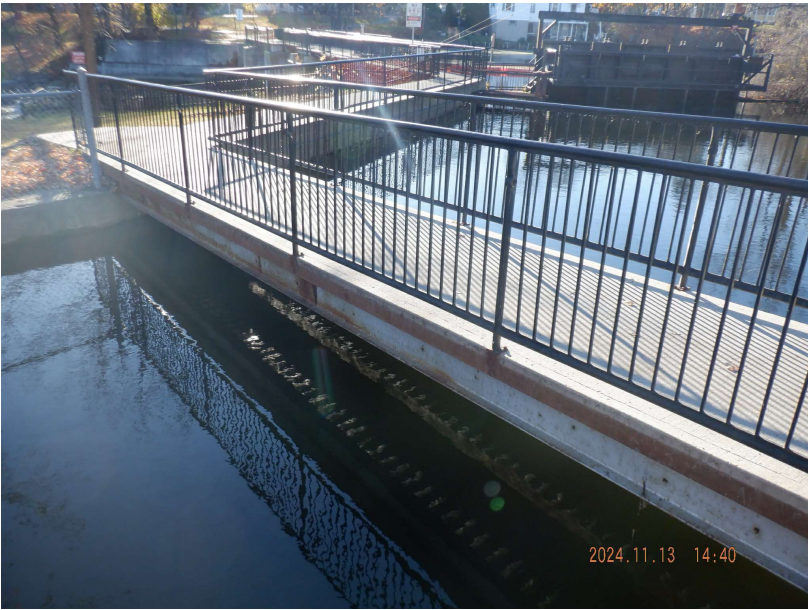
Figure 1 : East Elevation

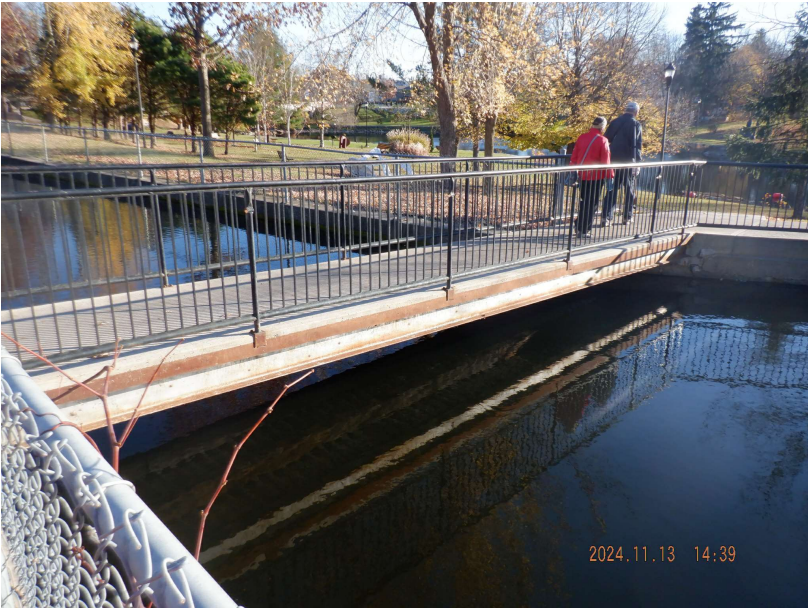
Figure 2 : West Elevation

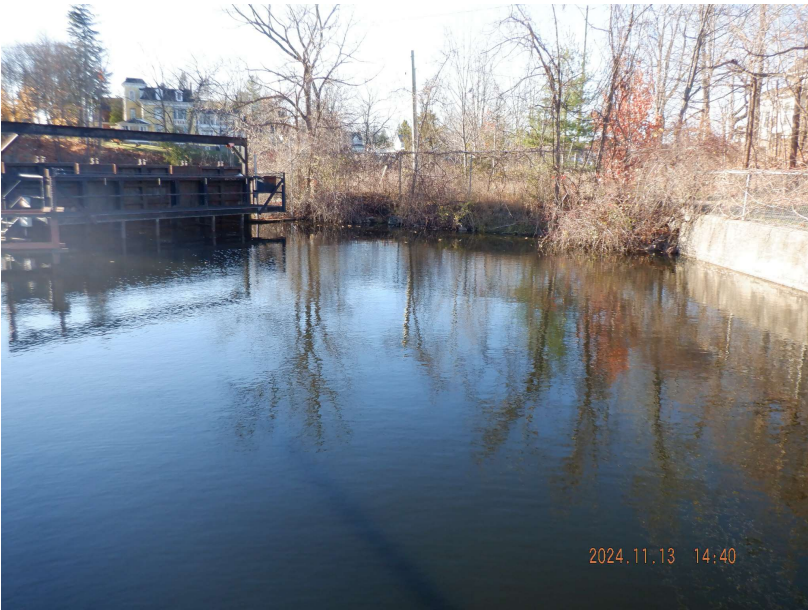
Figure 6 : Stream Looking West (U/S)

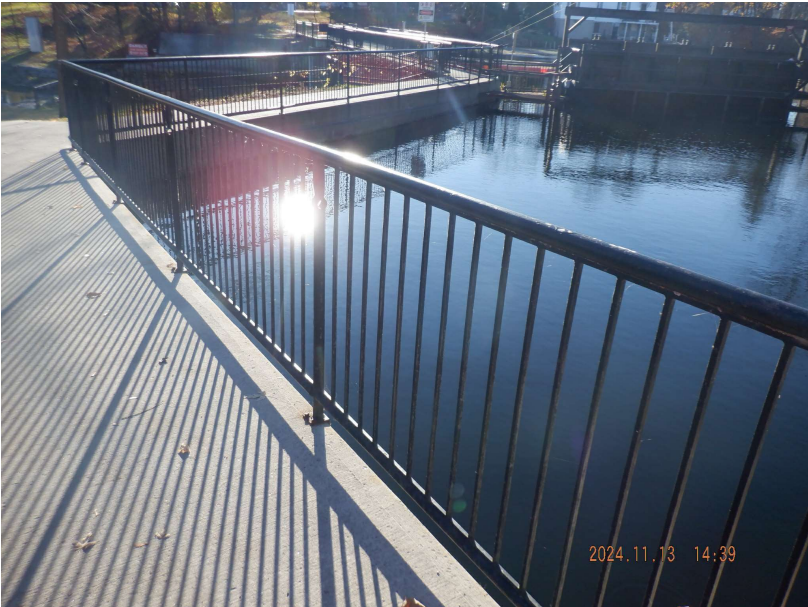
Figure 8 : West Railing

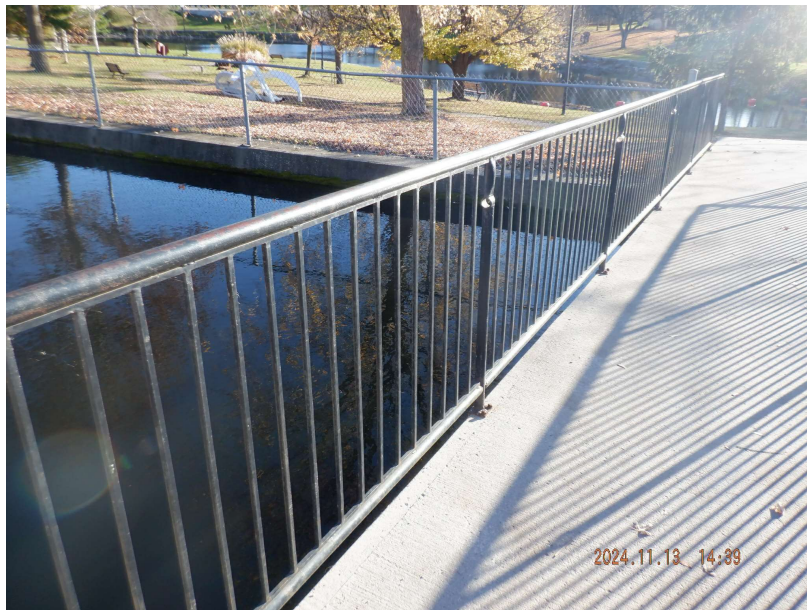
Figure 9 : East Railing

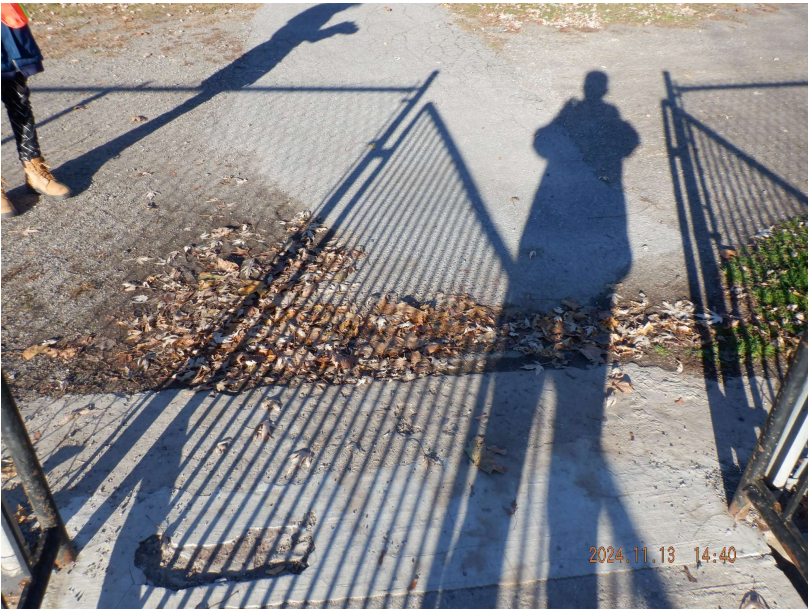
Figure 11 : North Approach

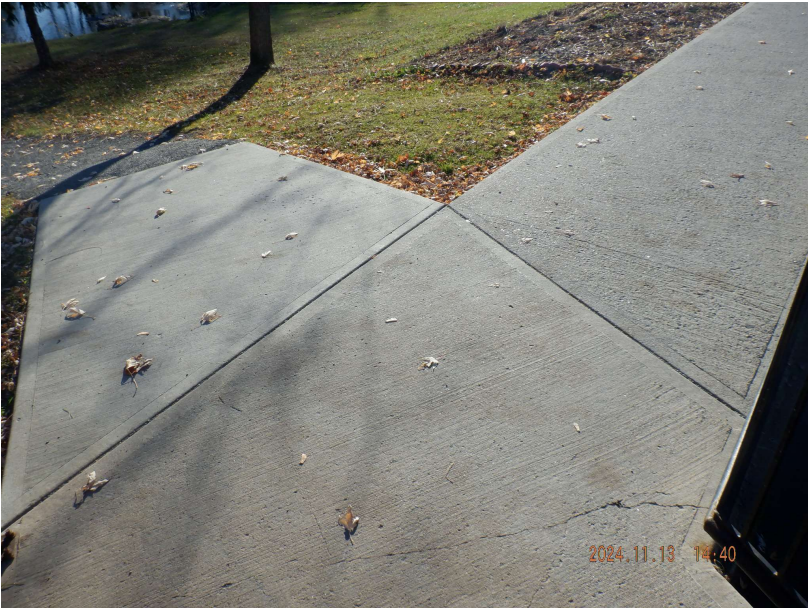
Figure 12 : South Approach

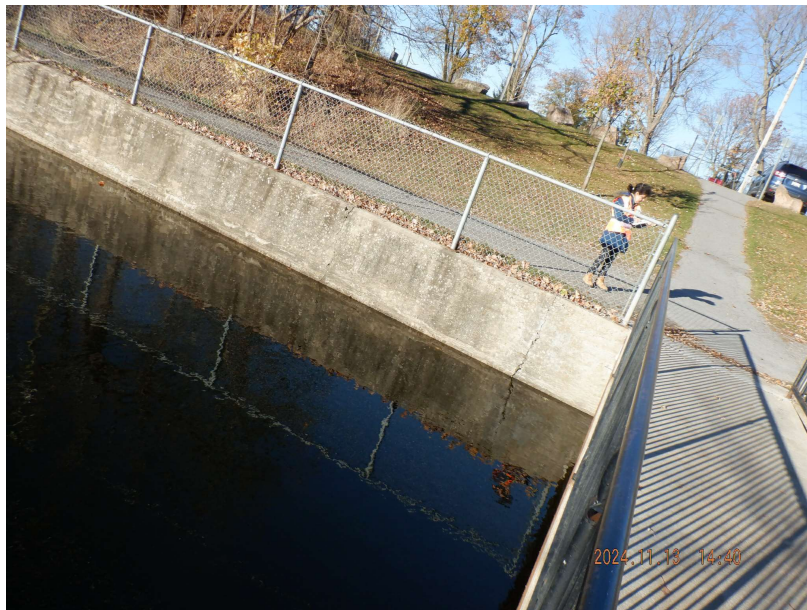
Figure 13 : NW Embankment

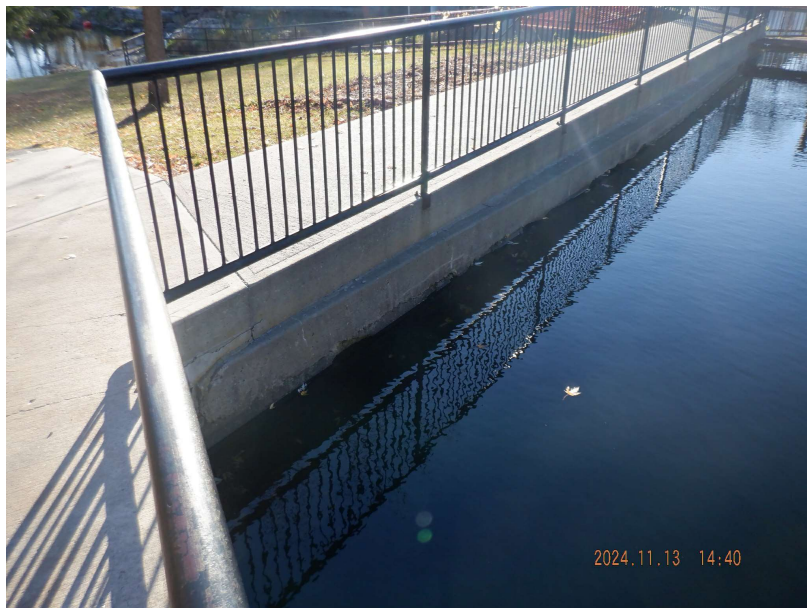
Figure 14 : SW Embankment

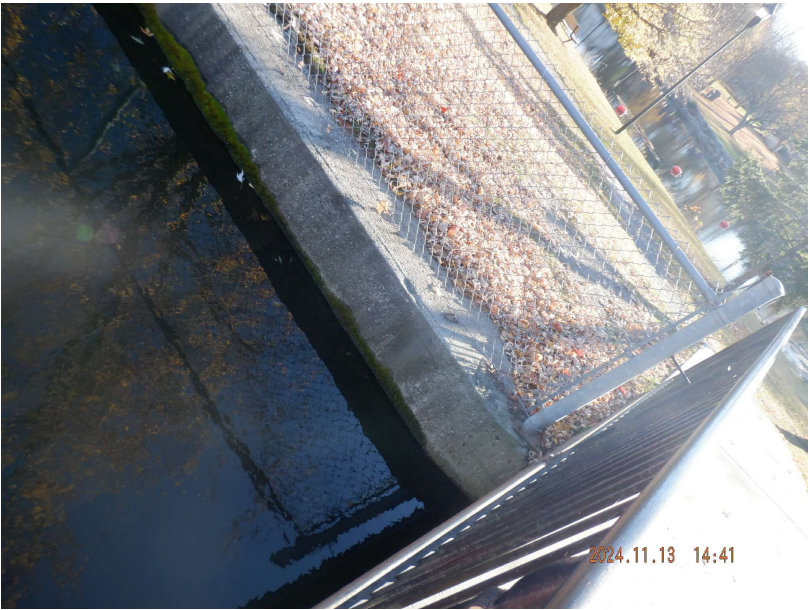
Figure 15 : SE Embankment

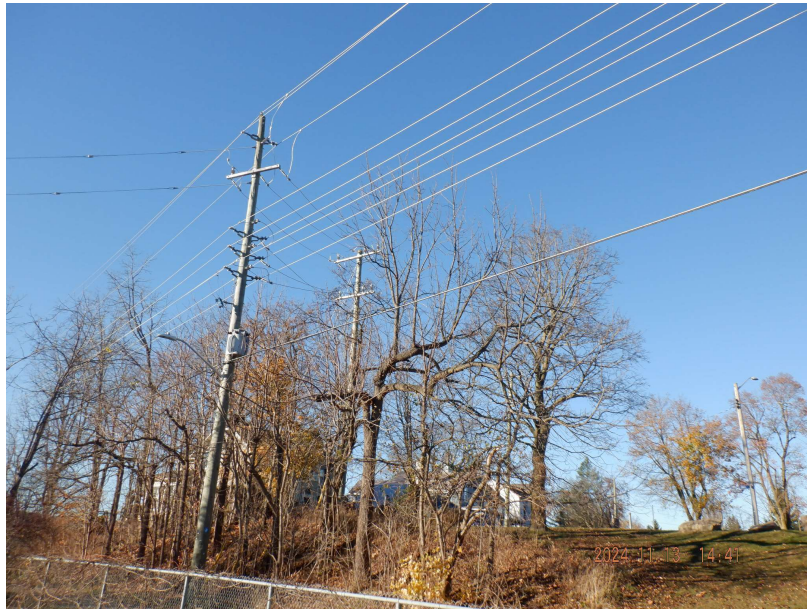
Figure 17 : Overhead Utility-North

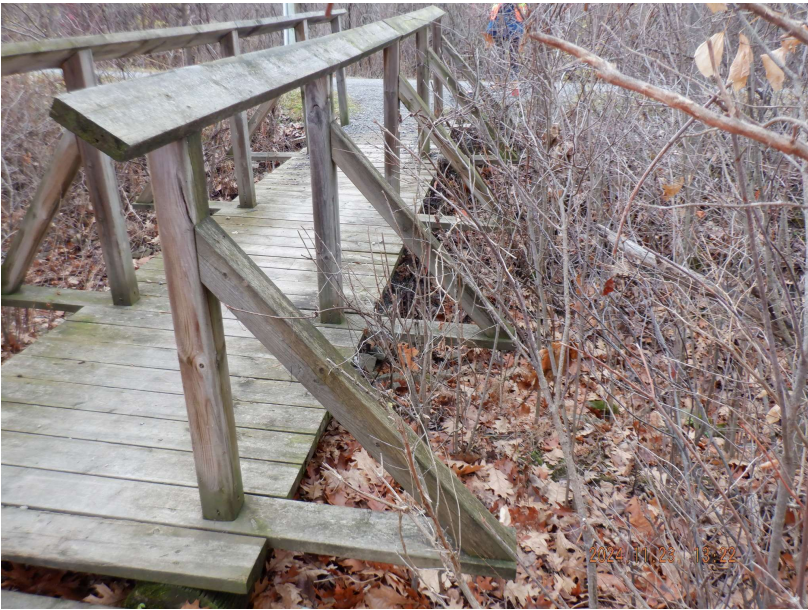
Figure 1 : North Elevation

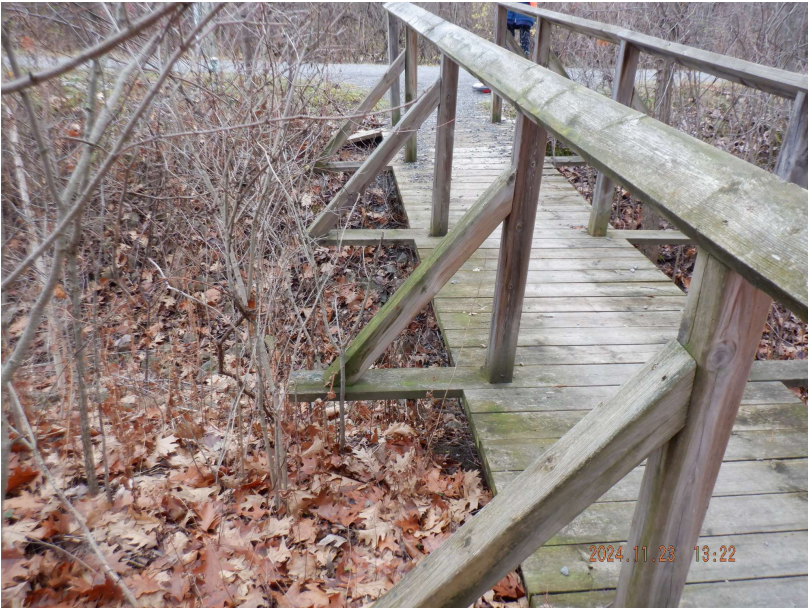
Figure 2 : South Elevation

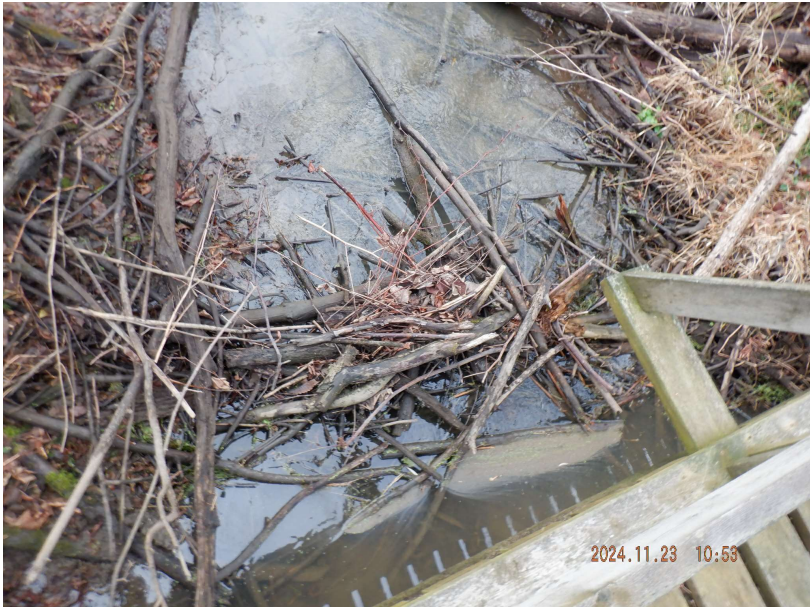
Figure 18 : Streambed-Evidence of Beaver Dam

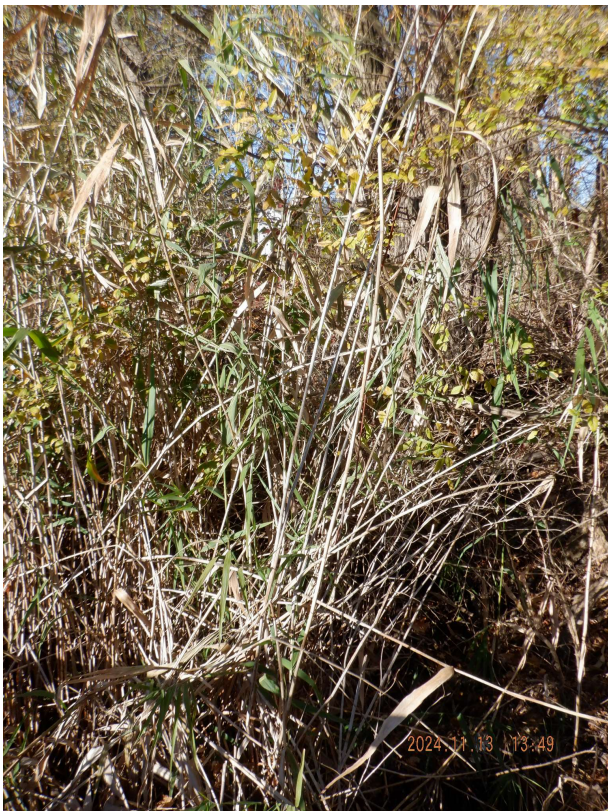
Figure 5 : Stream Looking North (U/S)-Evidence of Heavy Vegetation

<table><tr> <th colspan="3">Priority</th> </tr><tr> <td><b>Overall Comments:</b></td> <td colspan="4">Structure is generally in good condition. Evidence of localized severe rot on railing and weathering on soffit was noted. Maintenance need is recommended to remove heavy vegetation.</td> </tr></table>

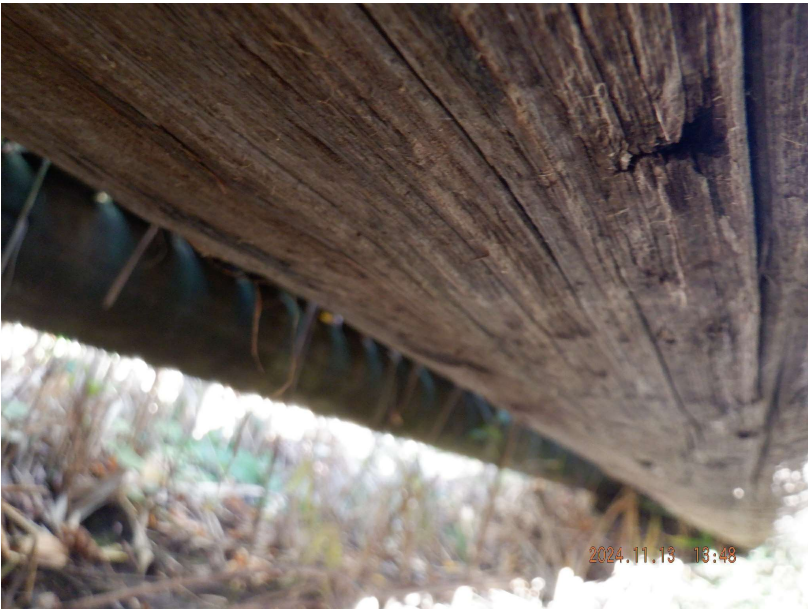
Figure 11 : Soffit (Typ.)

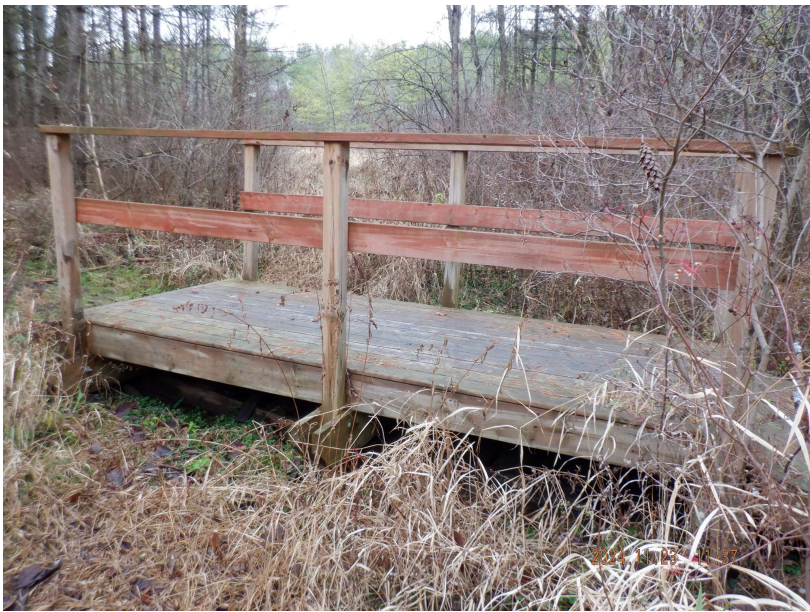
Figure 1 : East Elevation

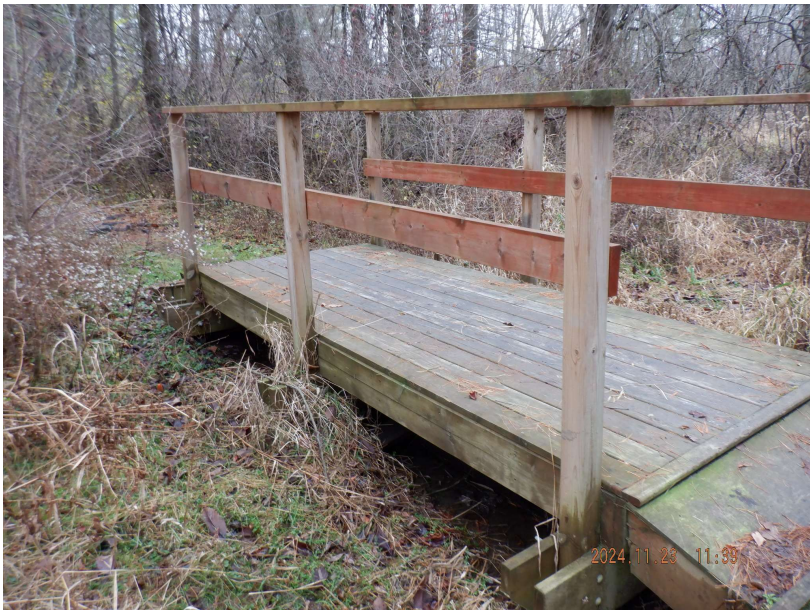
Figure 2 : West Elevation

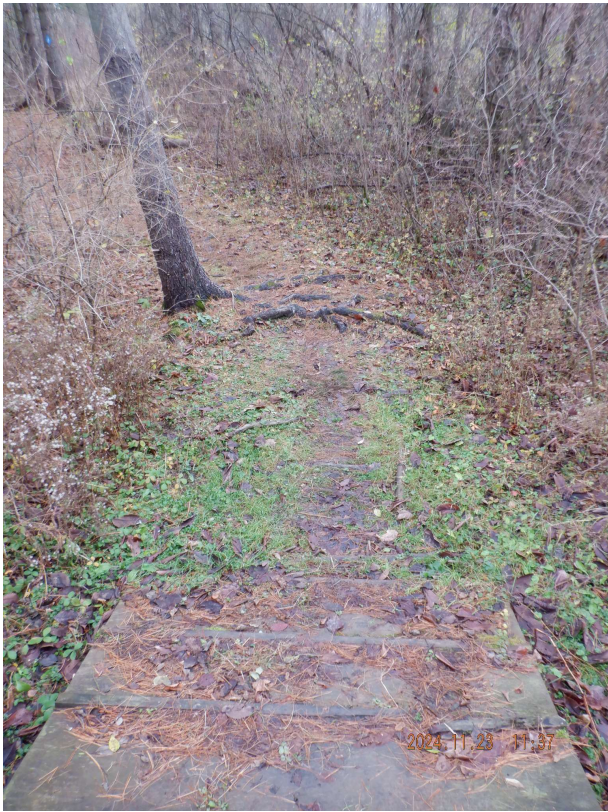
Figure 3 : North Approach

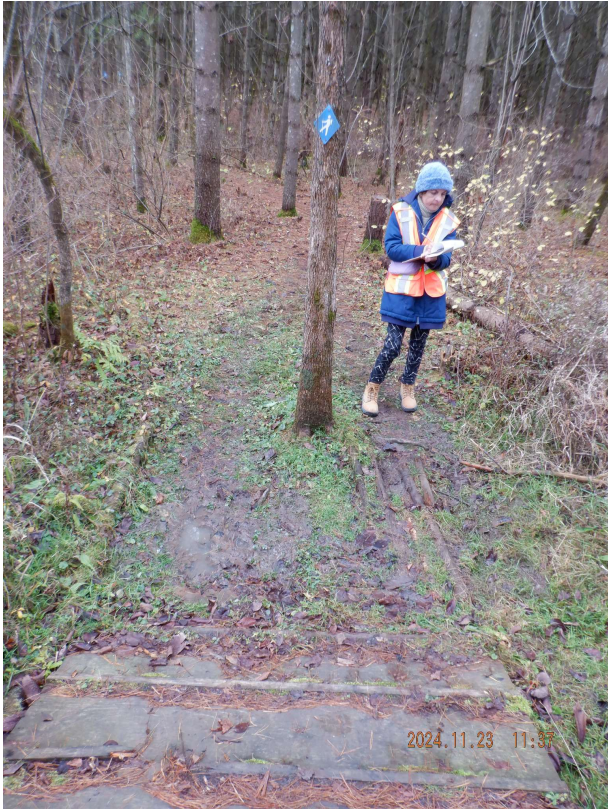
Figure 4 : South Approach

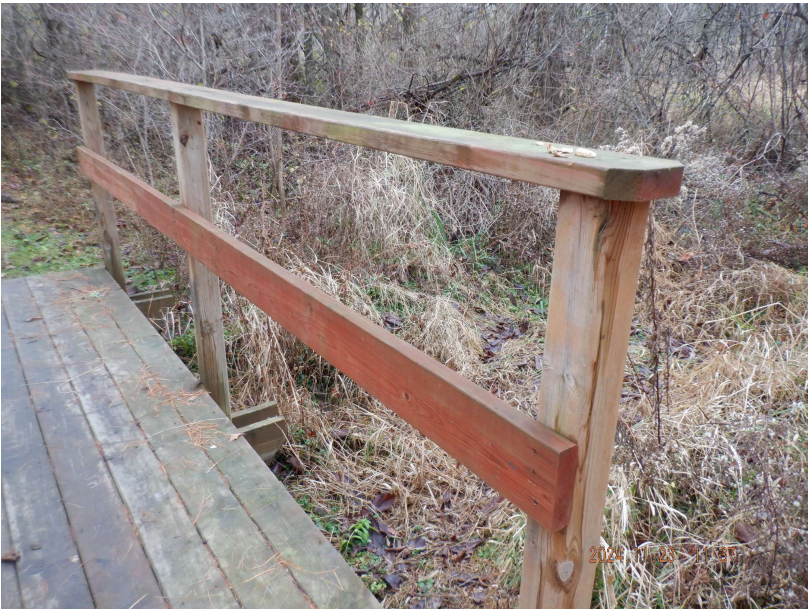
Figure 7 : East Railing

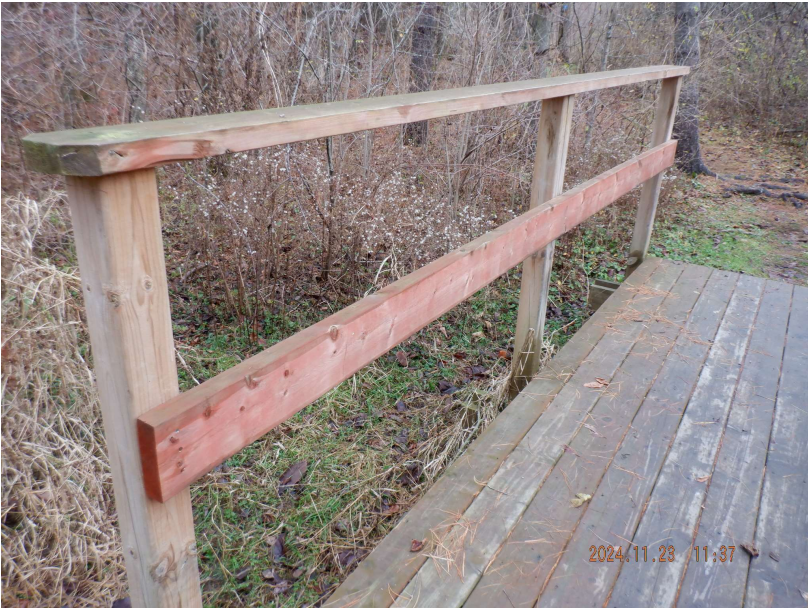
Figure 8 : West Railing

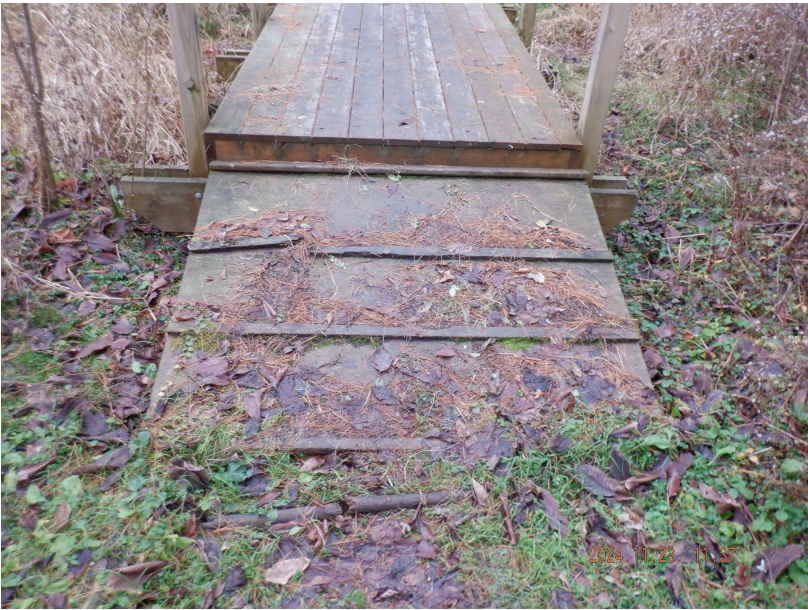
Figure 9 : North Ramp

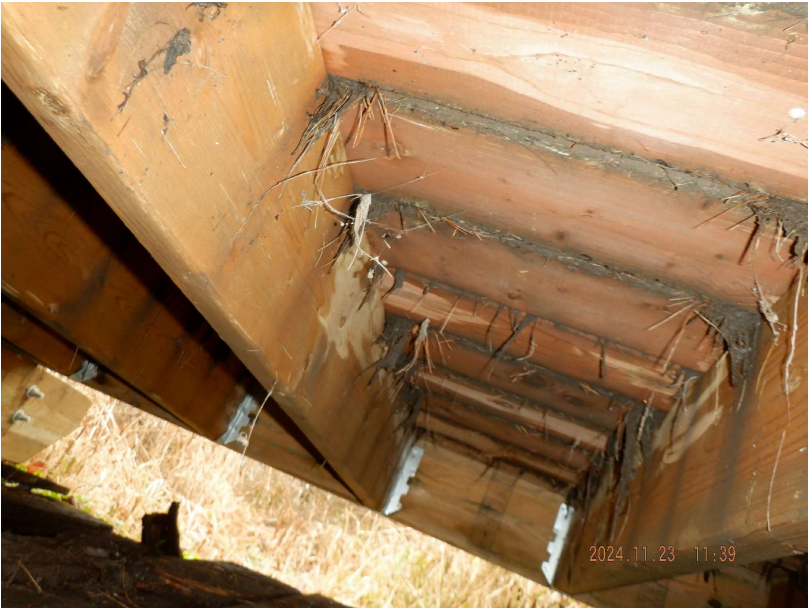
Figure 10 : Soffit (Typ.)
